Electrical Risks, Safety and Solutions for Older Homes

**PowerCheck Electrical Safety
Services**

February 20, 2008

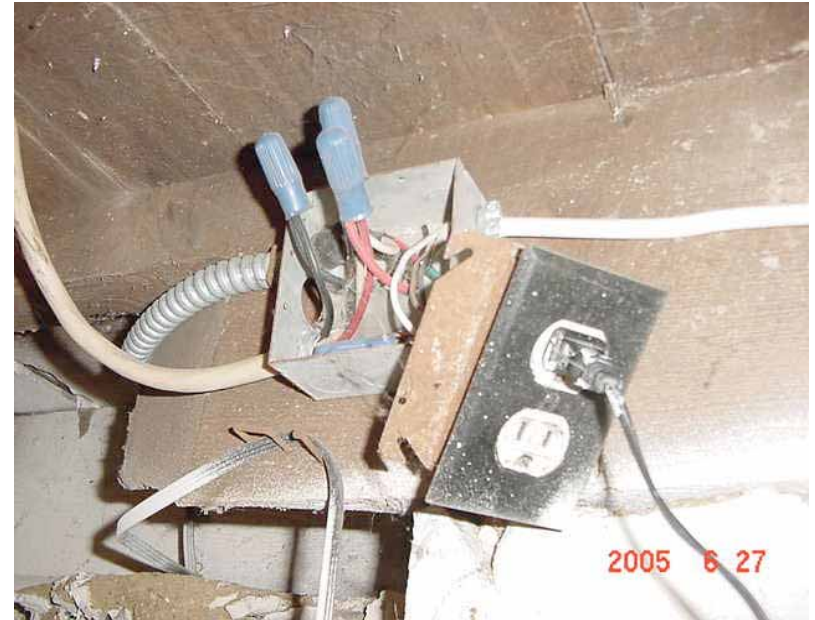
A NOT uncommon sight. Dangers like these found in 60% of pre-1950 homes, regardless of “New service upgrade”. This type of work is what causes fires

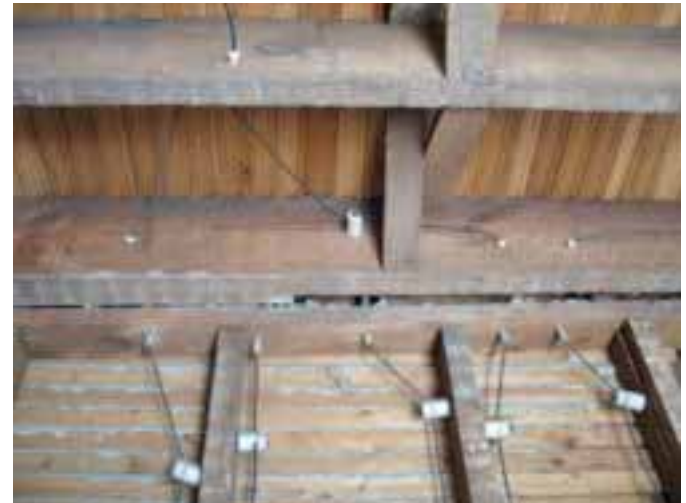
- Early standardized method of electrical wiring in homes
- Installed in all homes pre-1950
- Consists of
 - Two single insulated copper conductors run within wall and ceiling cavities
 - Supported by porcelain **knob** insulators
 - Insulated from joists and studs by porcelain **tubes**.

Typical Knob and tube wiring
in a 1930s home

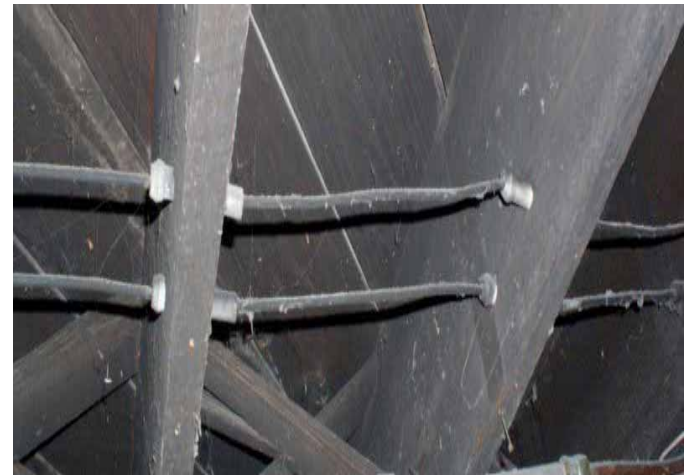
Ceramic tubes protected the wire from rubbing the wood joists.

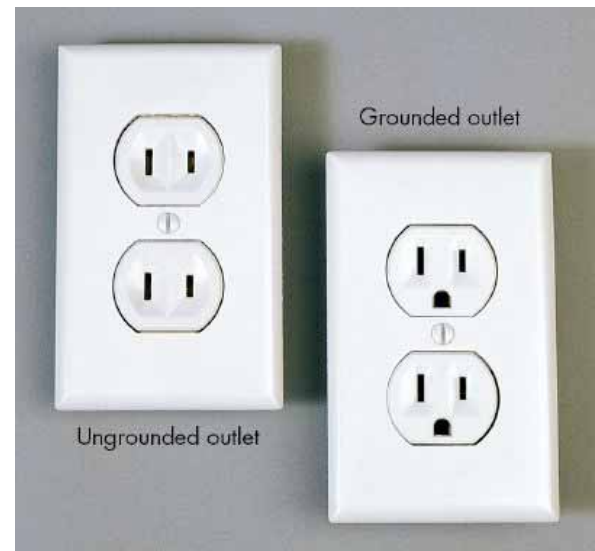
3-prong receptacles are often found swapped in place of the original 2-prong receptacle, giving impression of ground protection.

- The hazards are not due to a deficiency of the knob and tube wiring, but due to alterations from unauthorized personnel
- Examples:
 - 3-prong receptacles installed gives false impression of ground protection
 - Oversizing of fuses/breakers can lead to overloading resulting in insulation deterioration
 - Dangerous add-on circuits tapped onto the knob-and-tube conductors

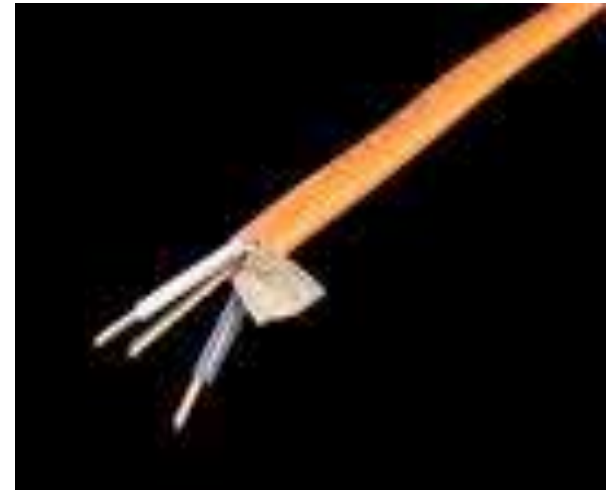
- **NMD3:** New cable introduced
 - with bonding conductor
 - Insulation rating still 60°C
- **NMD6:**
 - later introduced, with improved insulation rating of 75°C

NMD3 and NMD6 used predominately 1960s to 1984. While excellent for most applications, *not* suitable for recessed lighting.

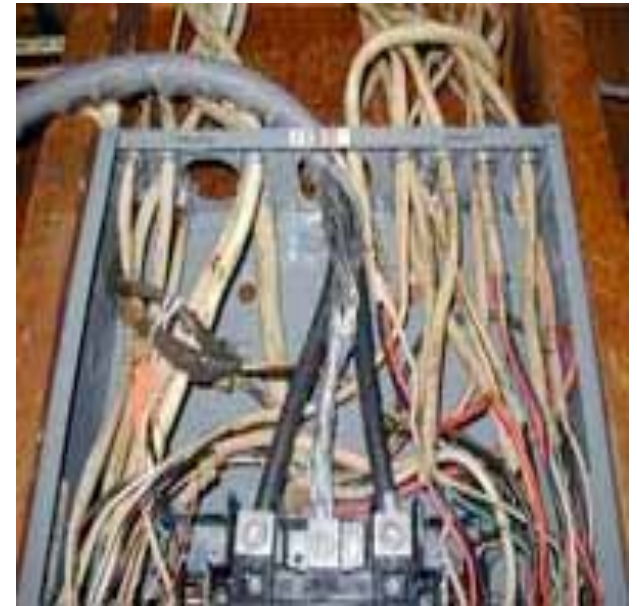
- **NMD7:** New cable introduced
 - With temperature rating of **90°C**
 - Suitable for ceiling lighting
 - Later NMD 90 introduced with PVC jacket

If not wired correctly, even modern NMD90 cable can be most dangerous

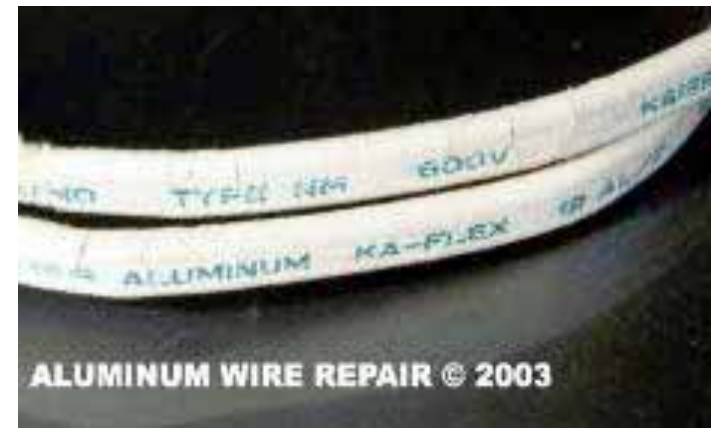
Aluminum wire, installed in the majority of houses 1965-1974

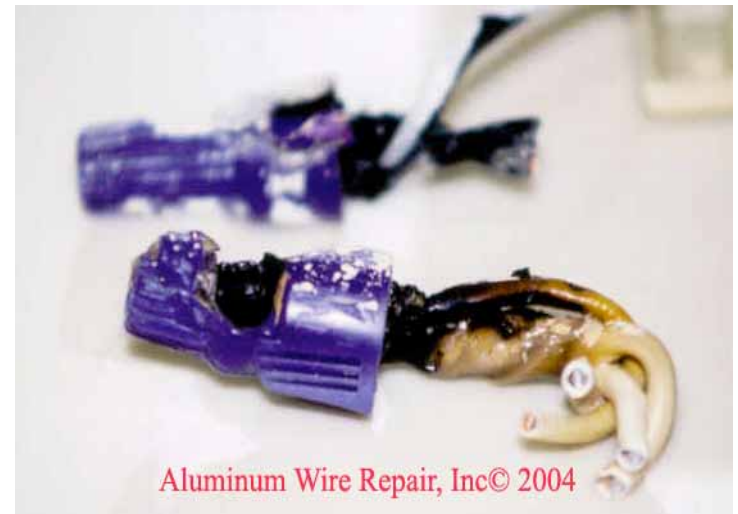
- ***“The problem with aluminum wiring is only at the connection point, the wire itself is fine” (NFPA, 2004)***
 - Poor connections at the point where aluminum meets copper can develop over time
- ***“Loose connections can potentially lead to hazardous arcs, glowing connections followed by fire” (NFPA, 2004)***

Poor connections lead to fire.

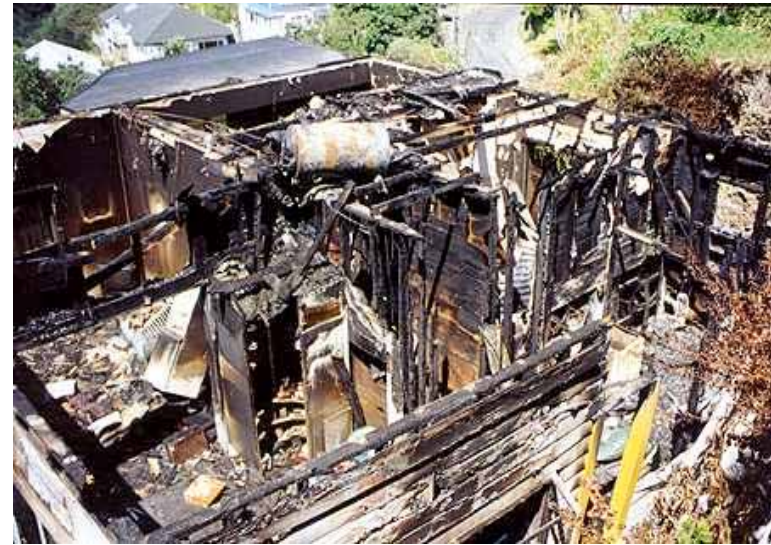
Aluminum-copper connections deteriorate over time, leading to fire

- It is likely not necessary to rewire a home with aluminum, however it must be checked regularly for electrical safety
- *“Each home will be different and must be assessed on its own. It is highly recommended the homeowner hire a licensed electrical contractor who is knowledgeable in the special techniques required for working with and repairing aluminum wiring” (Ontario ESA, 2004)*
- If home has not been checked since new, it is well overdue

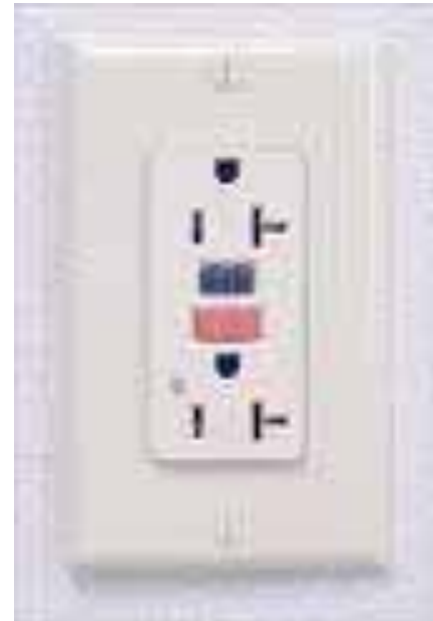
- Ground fault circuit interrupter (GFCI)
- **Providing all else is safe GFCIs provide an excellent solution for ground protection of ungrounded circuits (K&T or NMD1)**
- Available as:
 - **GFCI receptacles** or
 - **GFCI breakers**

Modern GFCI receptacle provides ground protection for ungrounded circuits

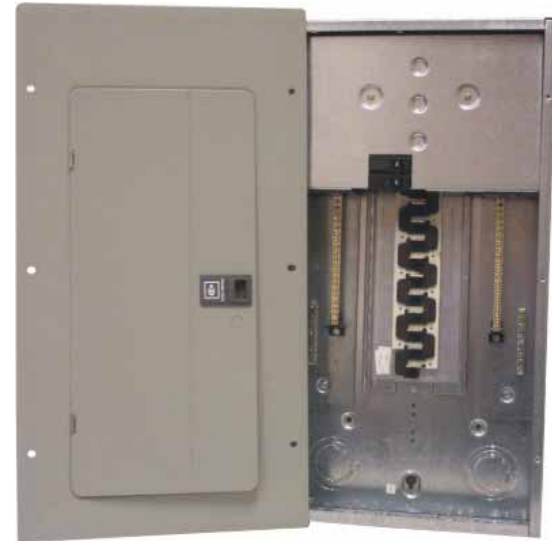
Do-it-yourself 100-amp service kits are readily available from retail stores. Image source: Home Depot

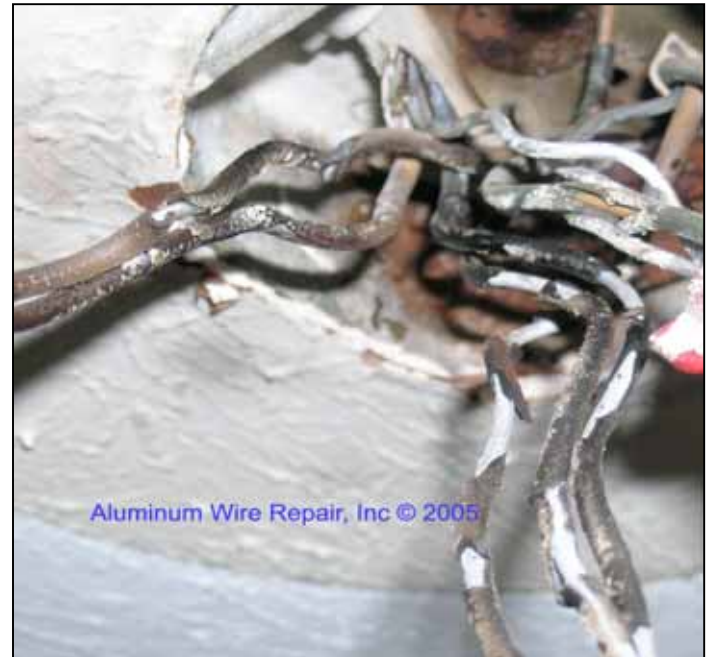
- Found in homes of all ages
- 20 and 30 amp circuit breakers or fuse in place of original 15 amp
- Can *easily* lead to insulation breakdown, arcing, followed by fire

Oversizing of fuses and breakers can easily result in overheated conductors as shown above.

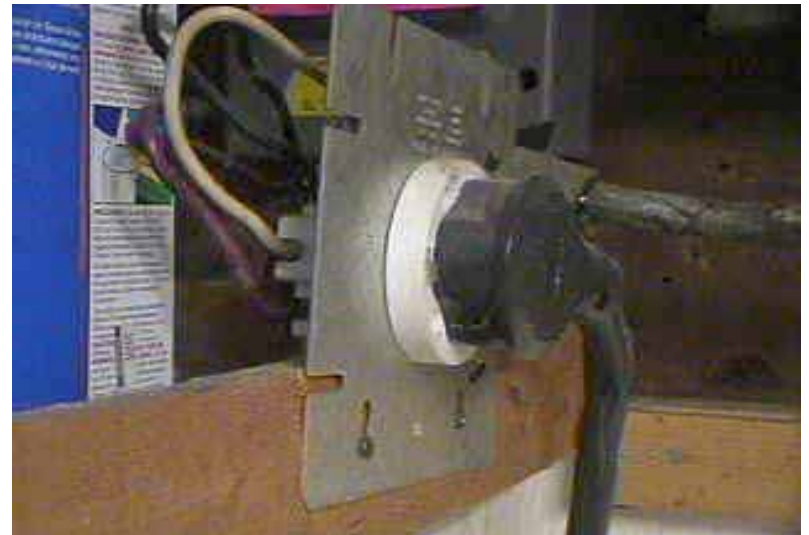
- Found in homes of all ages
- Particularly common with ceiling lights. The exposed connections often provide an easy opportunity for short circuits, arcing and fire

Lack of junction box is all too common in homes with add-ons wired by unauthorized individuals

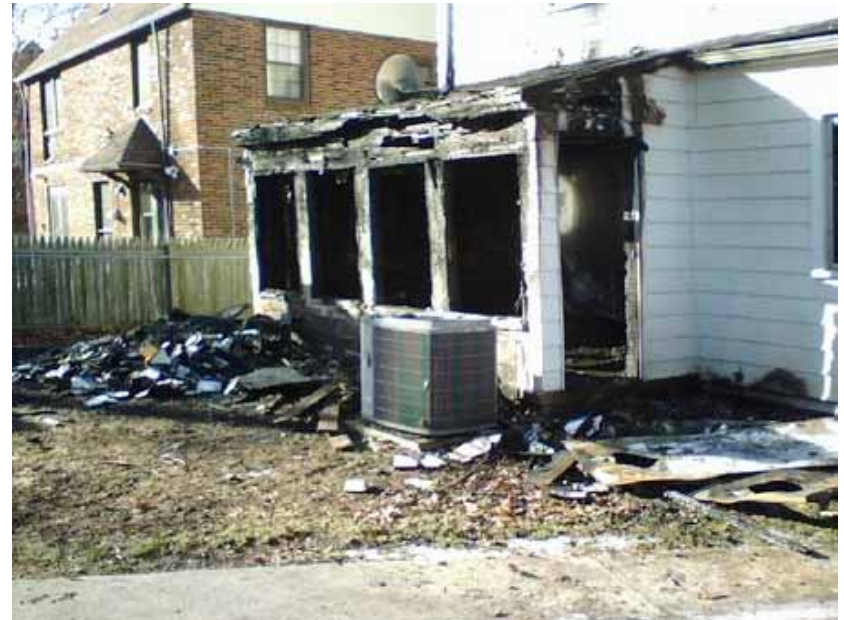
Dec 5, 2007, Akron, Ohio: “7 Firefighters said the fire began about 1 a.m. near an electric baseboard heater in the back of the house. In this house fire 3 children died, ages 6, 2 and 14 months” (source: The Plain Dealer, Cleveland News)

Baseboard heating in dangerous location

- Found in homes of all ages
- Baseboard heating installed
 - Under bookshelves
 - In contact with curtains
 - In vicinity of flammable material

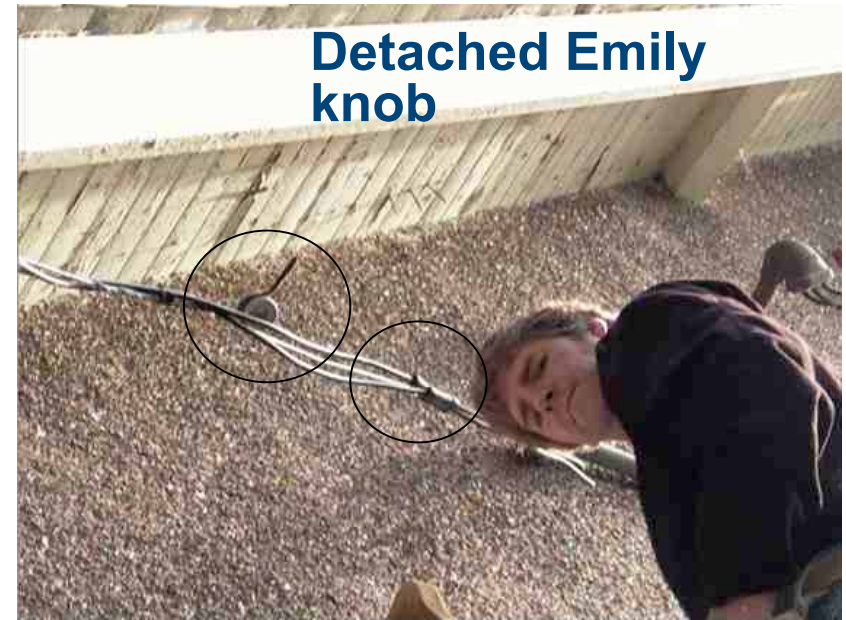
Emily knob has broken free from side of house (shown left) creating a fire hazard condition
