Electrical Risks, Safety and Solutions for Older Homes

Presented by:
Brian Cook

**PowerCheck Electrical
Safety Services**

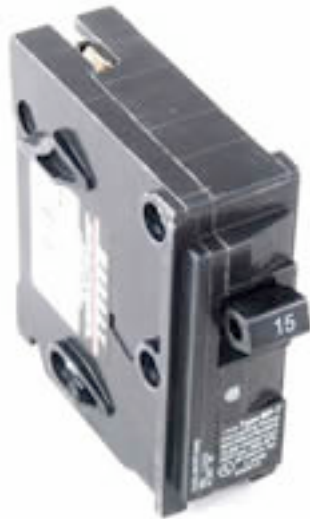
15 amp circuit breaker

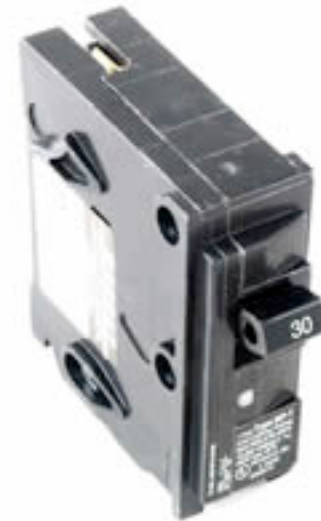
30 amp circuit breaker

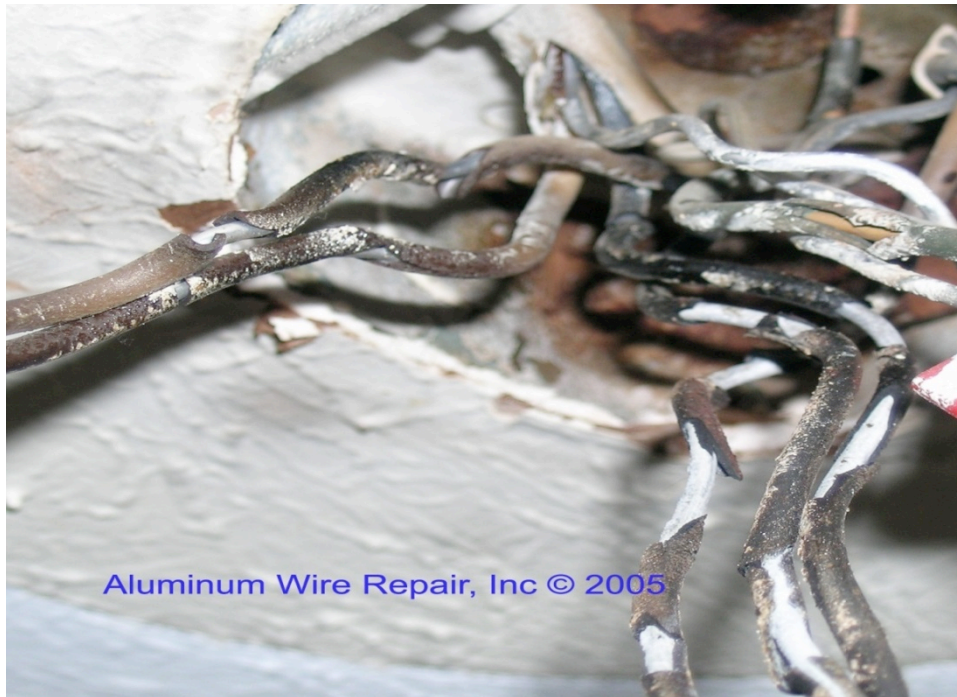
Overrated circuit breakers can result in over-heated conductors

The circuit breaker provides the protection of the wires from overcurrent. If the circuit breaker is oversized, it won't trip when needed

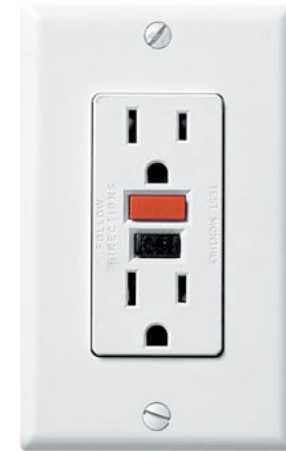
GFCI receptacle provides excellent ground protection.

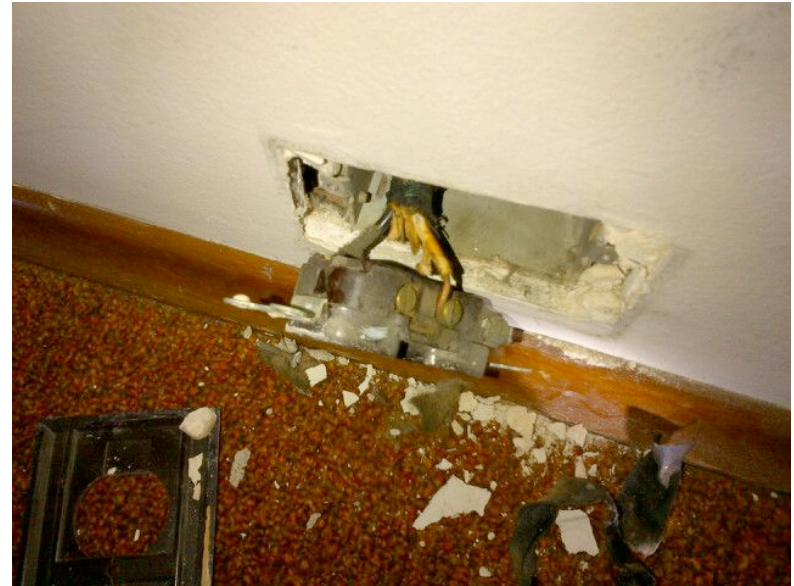
Ungrounded 2-prong receptacle
fed by “modern” cable, NMD1

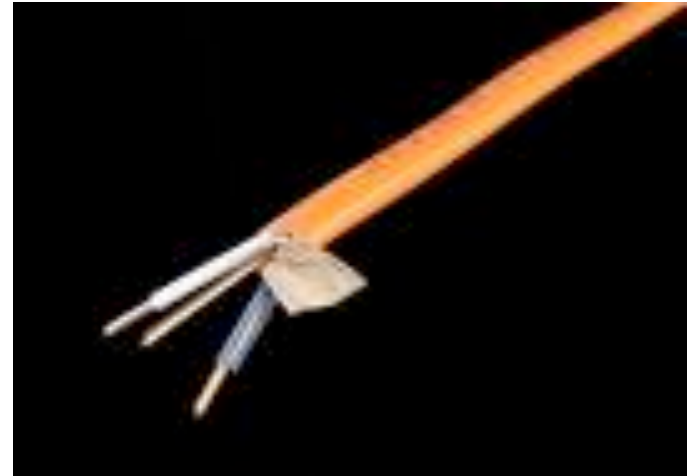
New cable of the 1960s
“NMD3 with ground”.

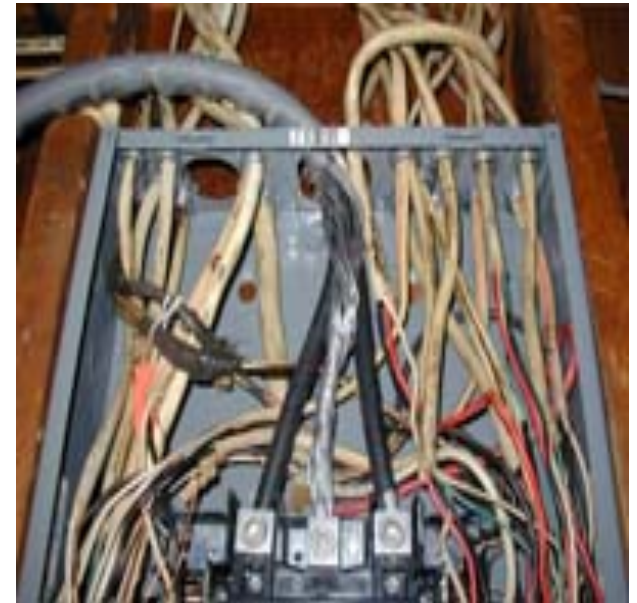
Modern cables: NMD7 & NMD90
But along with it comes “do-it-yourselfers”.

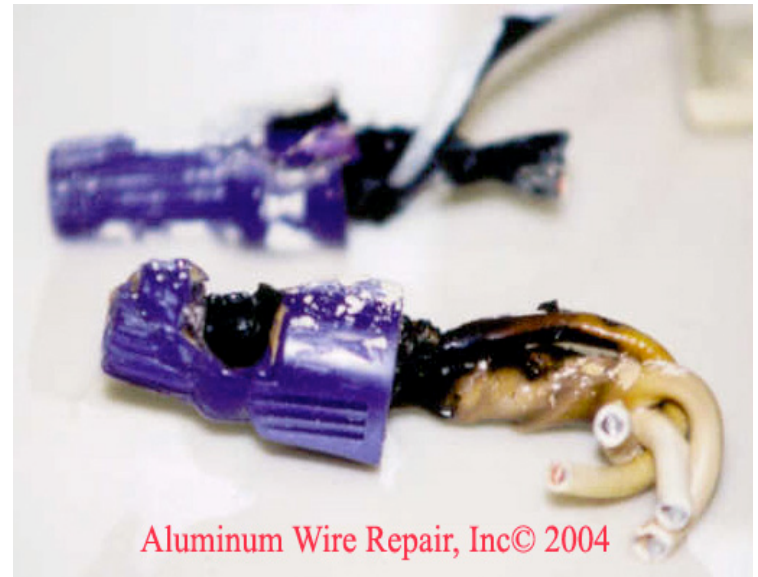
Aluminum-wiring pigtailing with
incorrect wire connectors;
commonly found.

**NOTE: “Approved” means
with the correct wire
connectors**

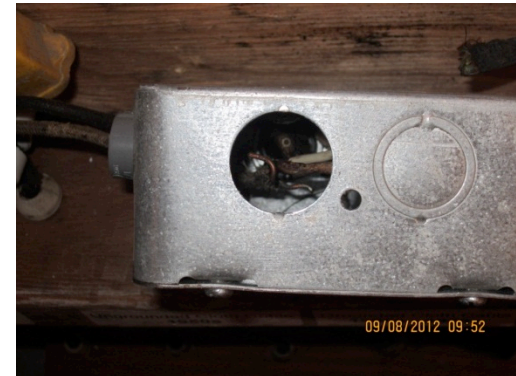
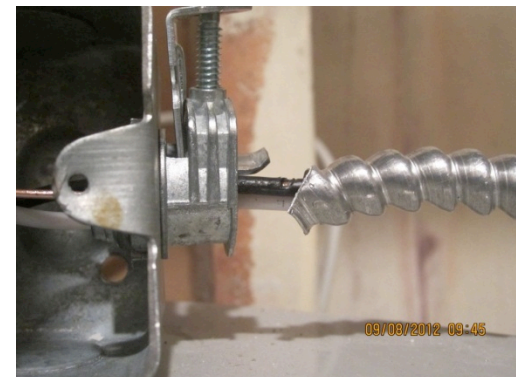
Exposed electrical connections

If connections become at all loose they will arc, easily igniting surrounding wall material.
