# Electrical Risks, Safety and Solutions for Older Homes

**PowerCheck Electrical  
Safety Services**

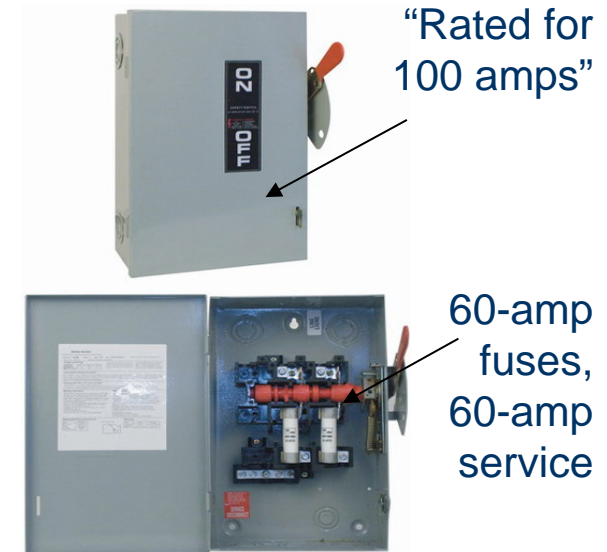
Old service boxes often have the wording "***Rated for 100 amps***". This refers to the box rating, not service size.

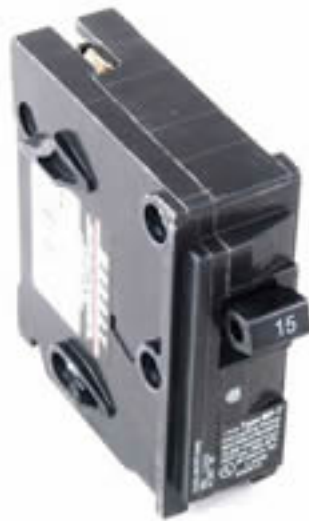
**15-amp** circuit breaker

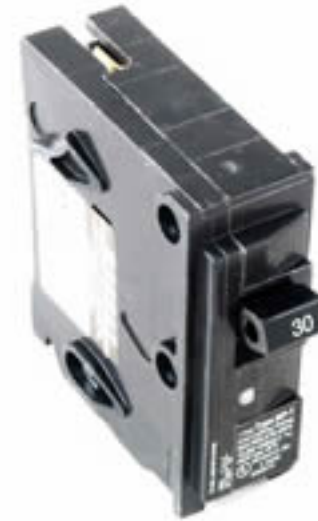
**30-amp** circuit breaker

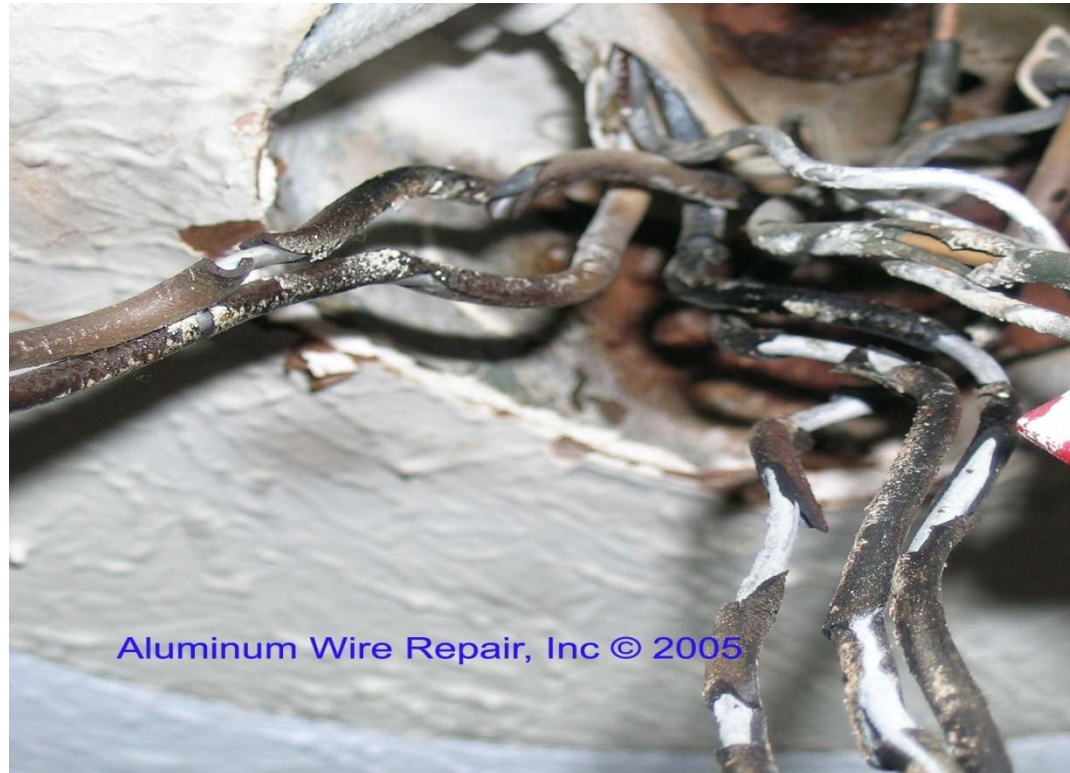
...can create over-heated conductors

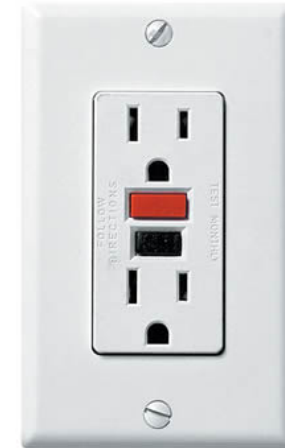
GFCI receptacle provides excellent ground protection. It disconnects the power if leakage to ground exceeds 5 mA.

Therefore, GFCIs can provide the necessary ground protection:  
**\$20 each**

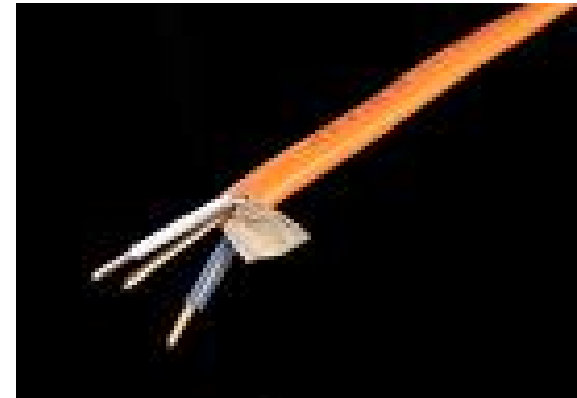
Introduced in the late 1950s: “NMD3”. Same characteristics as NMD1 but provided ground protection: Still not suitable for recessed lighting.

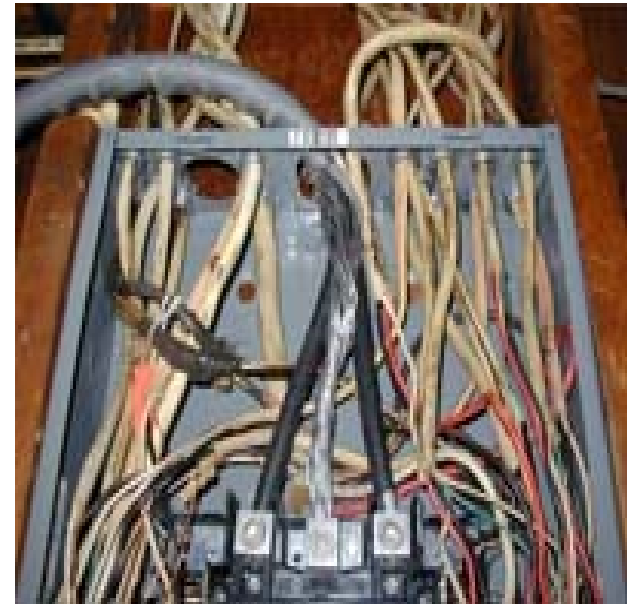
Modern wiring, NMD7 & NMD90 become the standard, but along with it comes “do-it-yourselfers”.

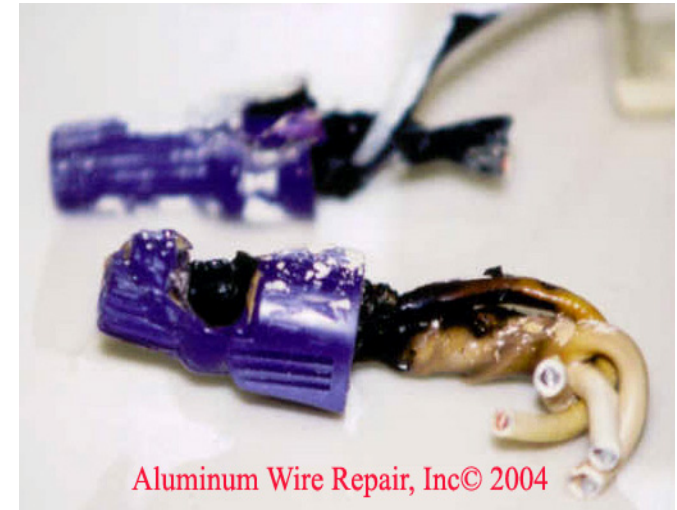
Many authorities recommend regular maintenance every 15 years.

*“If home [with aluminum wiring] has not been checked since new, it is high time overdue” (NFPA).*

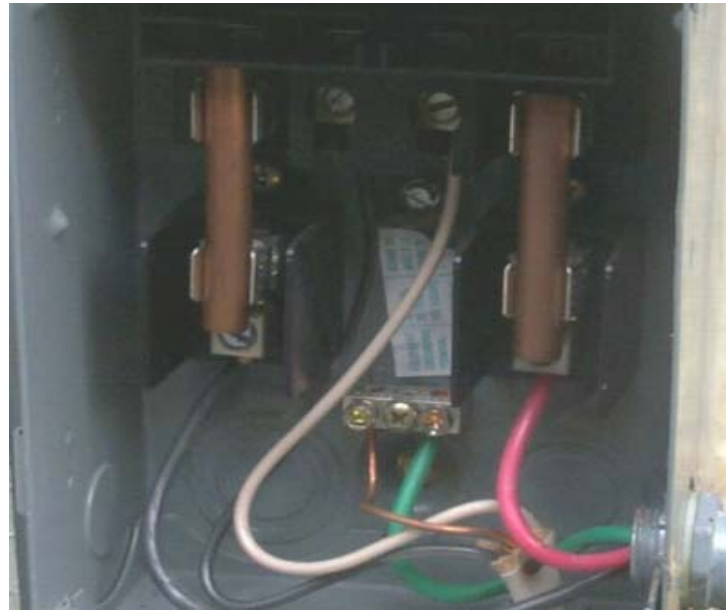
Here client has replaced main fuses with metal bars, eliminating over-current protection, creating a fire hazard condition.

This exact scene was found by PowerCheck in an older home in Vancouver earlier this year. **Home was sent to us because of knob-and-tube wiring.**

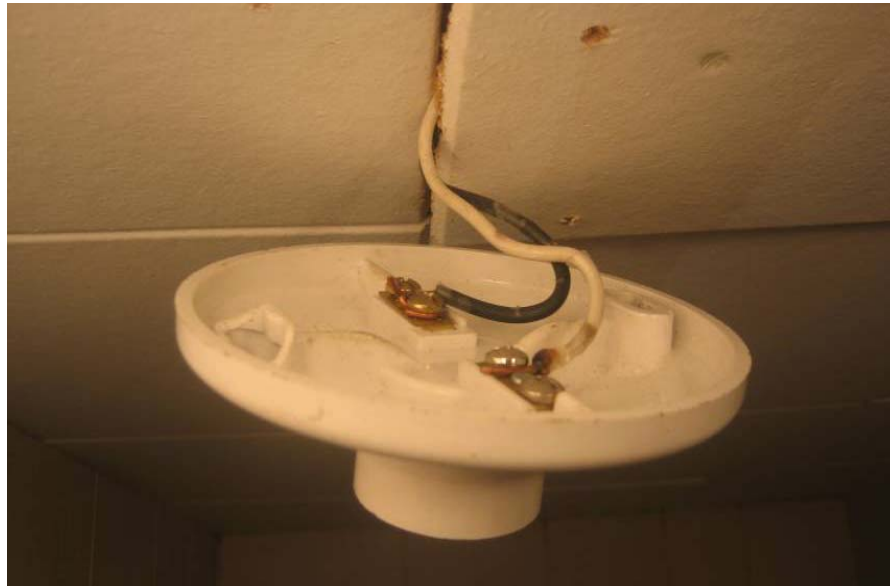
If connections become at all loose they will arc, easily igniting surrounding ceiling material.

Commonly found in older homes where electrical wiring was done by home-owner or unqualified person. **Home was sent to us because of knob-and-tube wiring.**

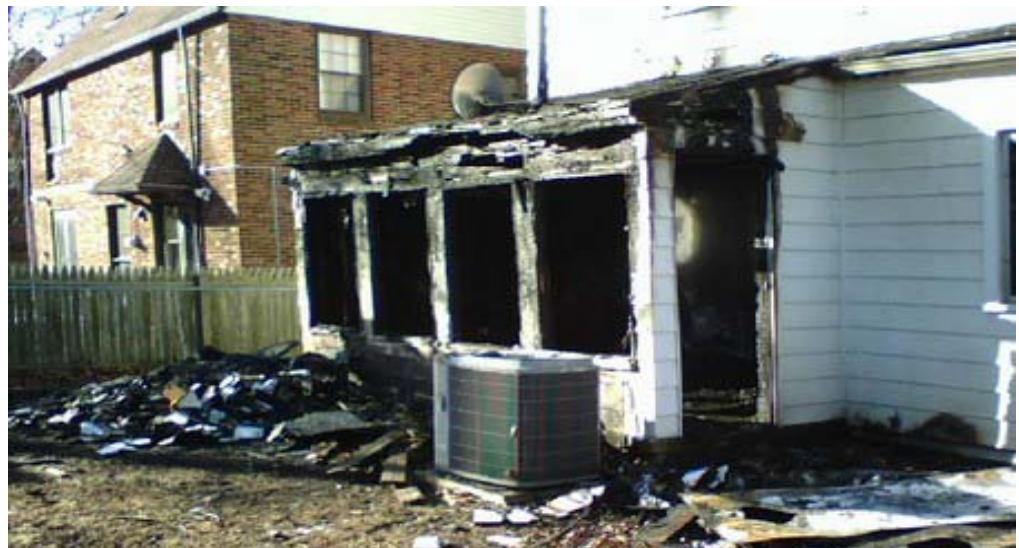
Individuals installing electrical equipment without being thoroughly knowledgeable on the electrical code, can easily result in electrical fires.

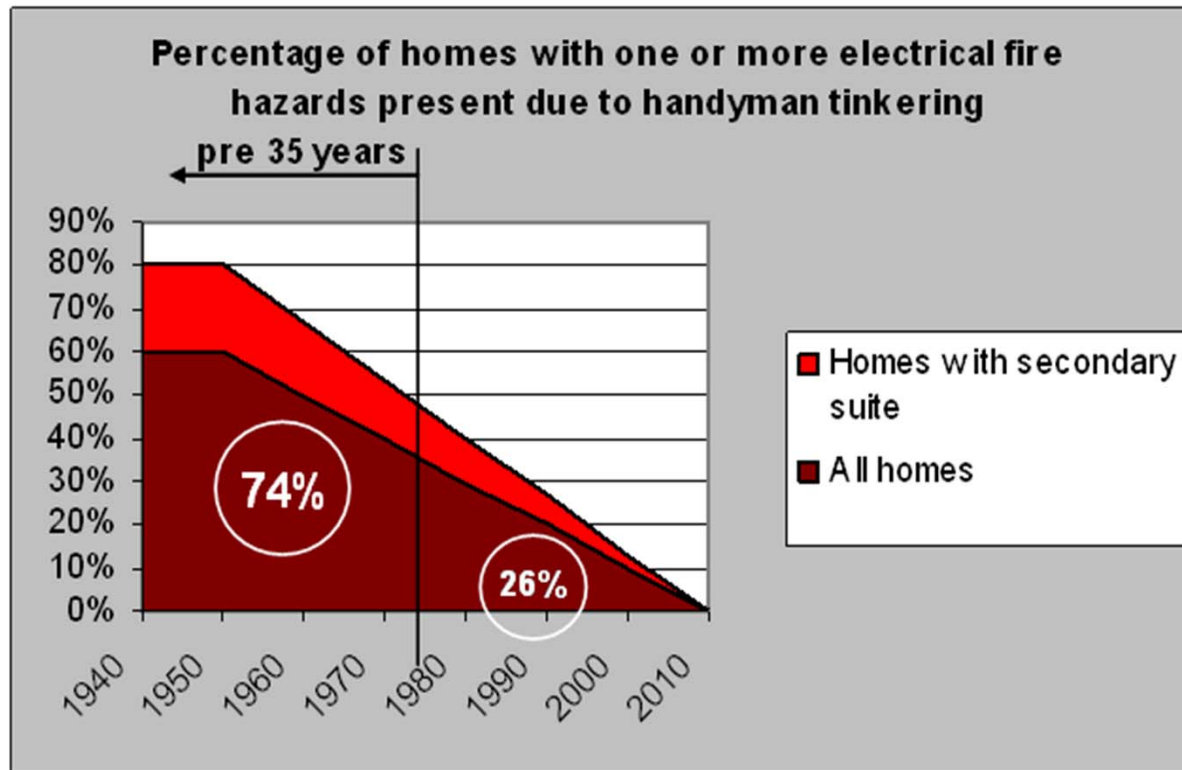
# Probability of risk increases with age

If all homes greater than 35 years were checked, we would catch **74% of homes** with electrical fire hazards.
