Old Homes – Electrical Risks Explained

For the insurance
industry

Risk leading to structural fire due to faulty electrical system

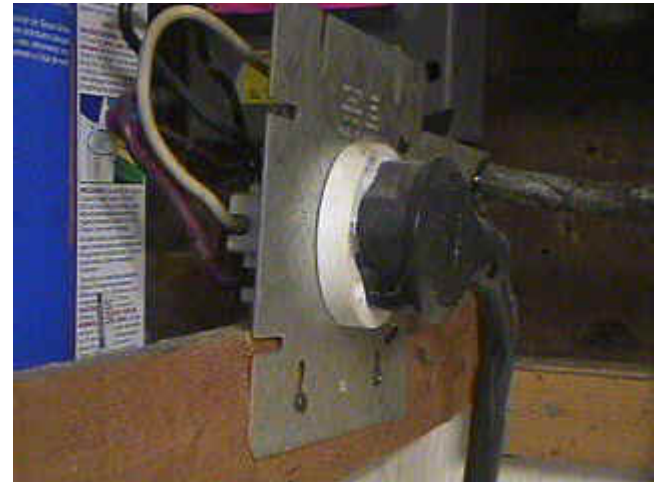
VERY Dangerous: no electrical box. Incredibly common with handyman add-ons.

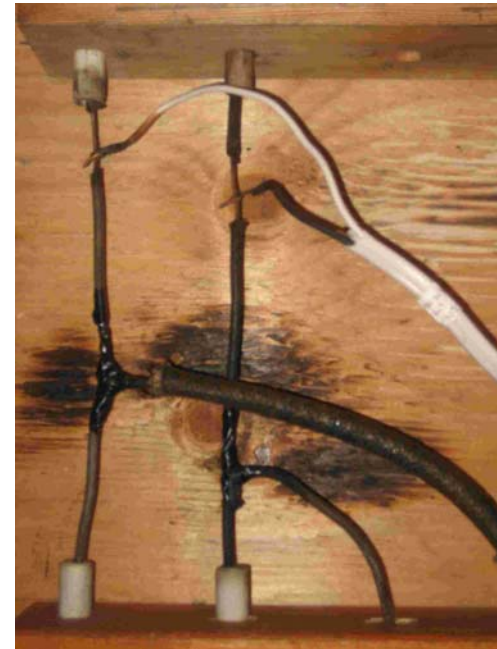
Knob-&-tube with dangerous handyman add-on (white cable). Burn marks on ceiling indicate connections are soldered - *not* a sign of poor connections.

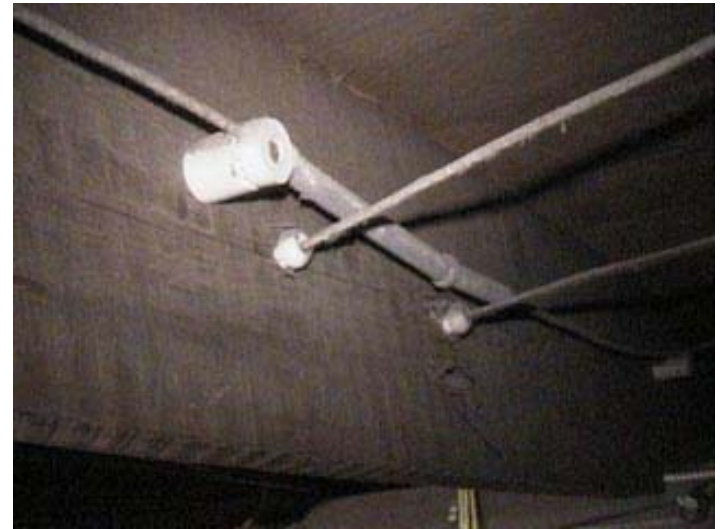
Knob and tube was seldom installed by non-professionals.

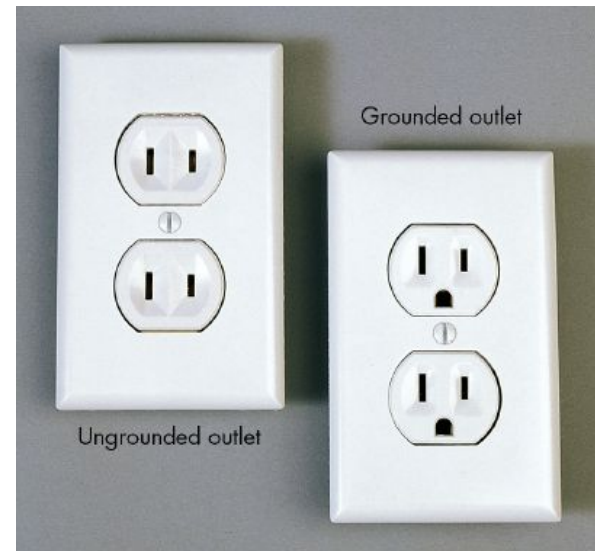
3-prong receptacles are often found swapped in place of the original 2-prong receptacle, giving impression of ground protection.

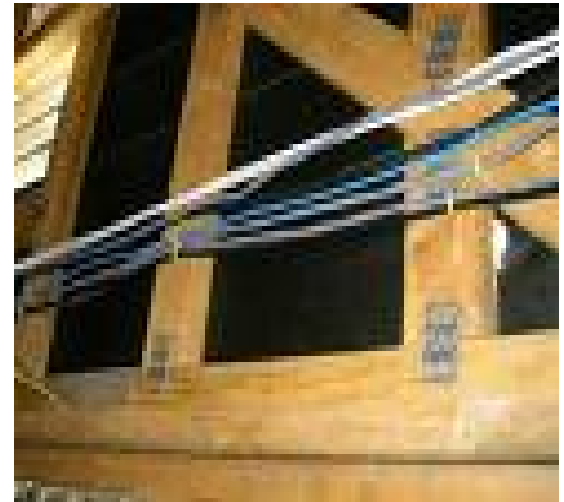
Common in houses 1950-1962, a black, twin-conductor cable with no ground wire. Wired to 2-prong ungrounded outlets

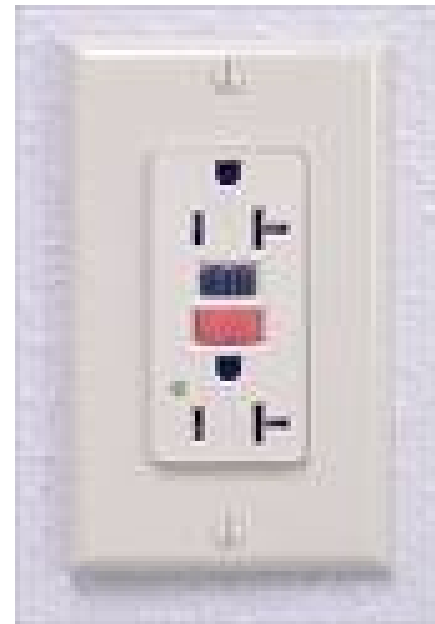
Modern GFCI receptacle provides ground protection on ungrounded circuits

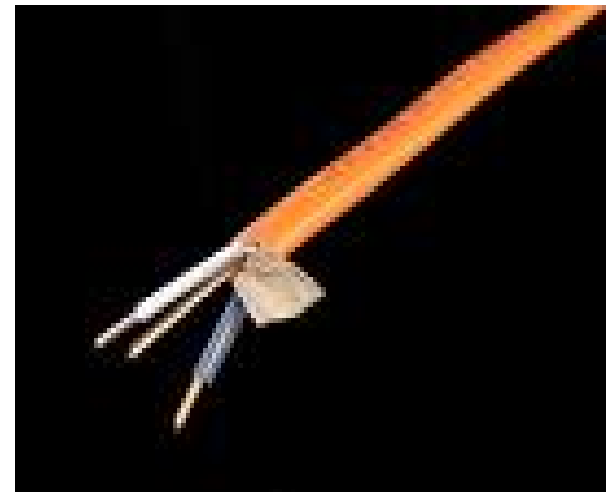
Paper-wrapped cables used predominately 1960s to 1984. While excellent for most applications, *not* suitable for recessed lighting.

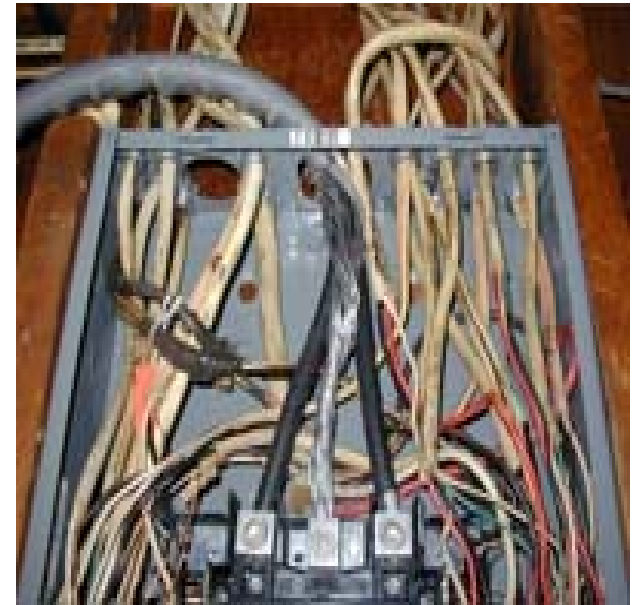
If not wired correctly, modern electrical cable can be most dangerous

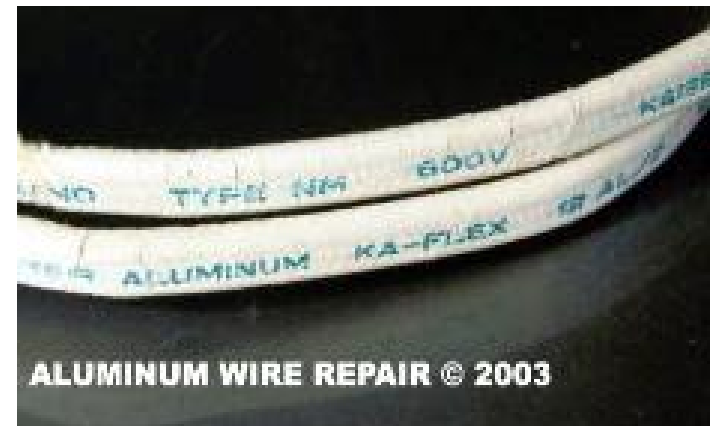
Aluminum wire, installed in the majority of houses 1965-1974

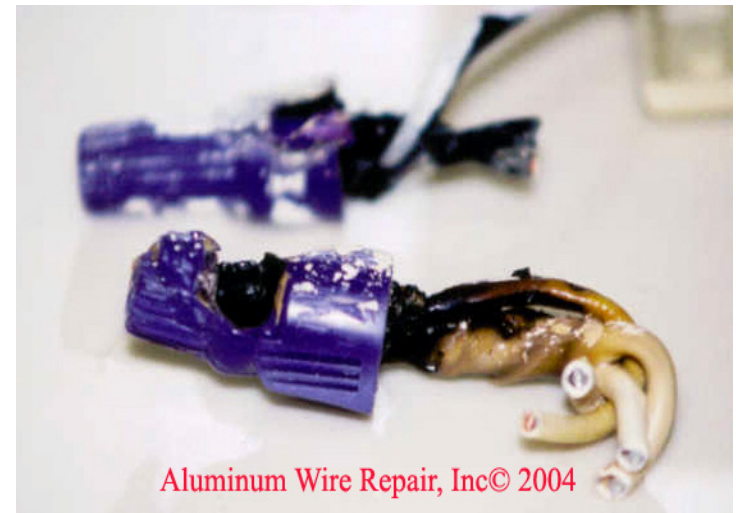
Poor connections lead to fire. A common sight where aluminum conductors meet copper

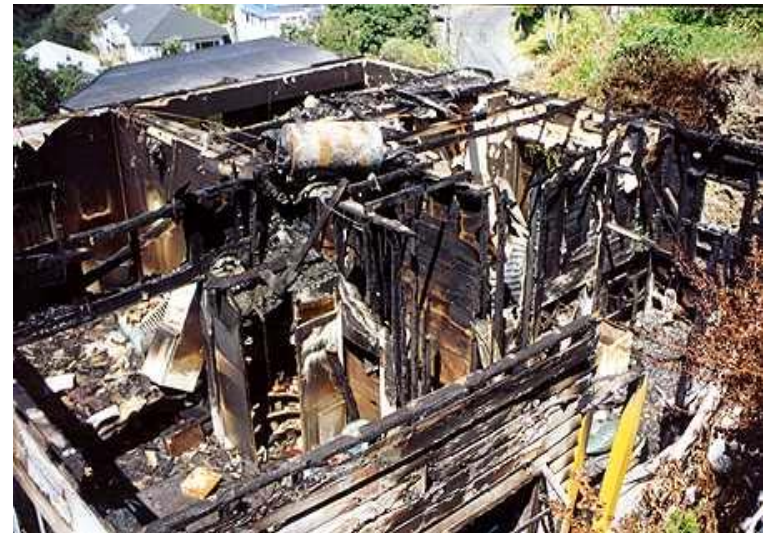
Aluminum-copper connections deteriorate over time, leading to fire

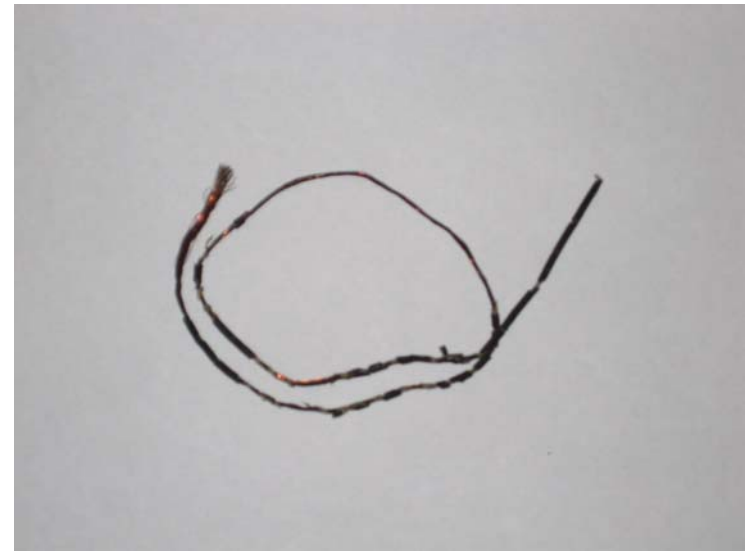
Image of extension cord wiring found in Vancouver home, which was stapled on wooden joist. Extraordinary that the house did not burn

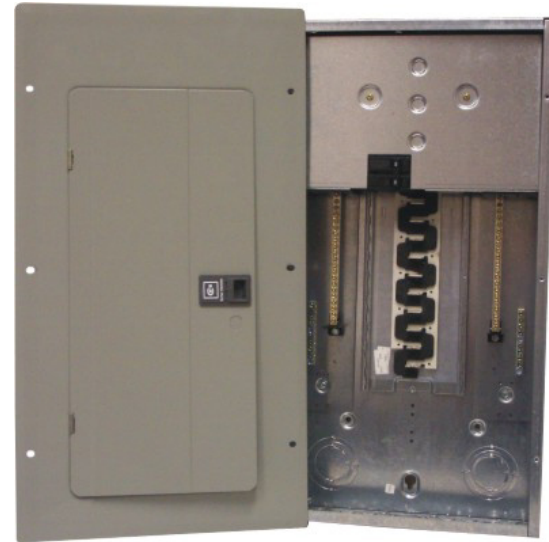
Do-it-yourself 100-amp service kits are readily available from retail stores. Regardless of size, a staggering number of “modern services” are installed incorrectly. Image source: Home Depot

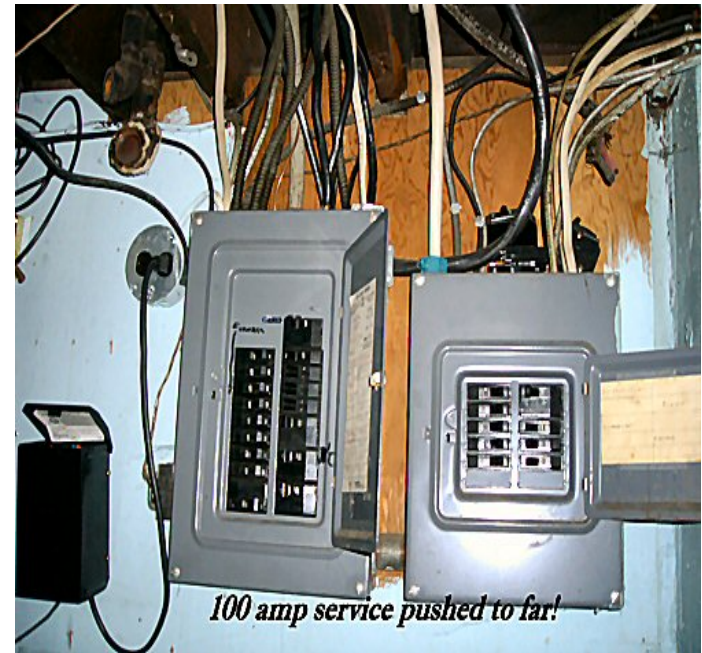
100-amp service with modern circuit breakers does not imply it is safe. Service here installed by a handyman

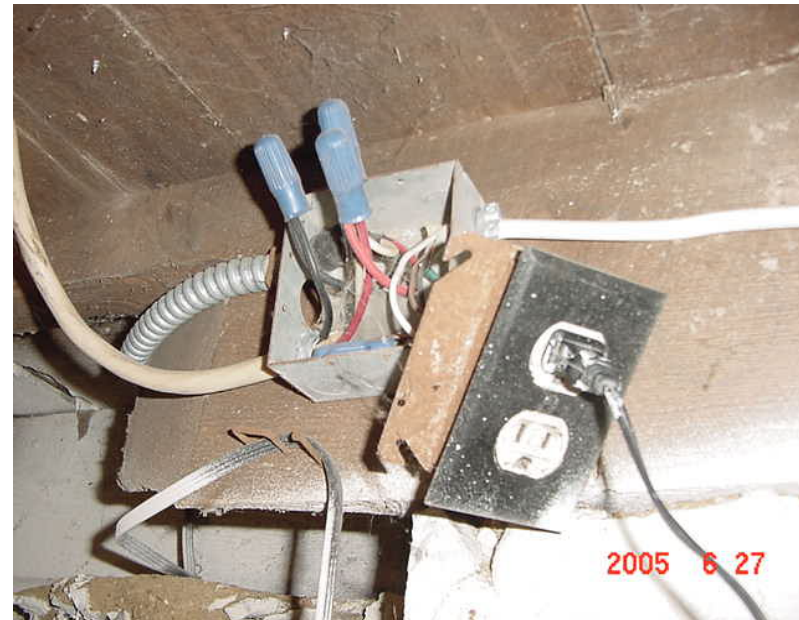
A NOT uncommon sight. Dangers like these found in 60% of pre-1950 homes, regardless of “New service upgrade”. This type of work is what causes fires

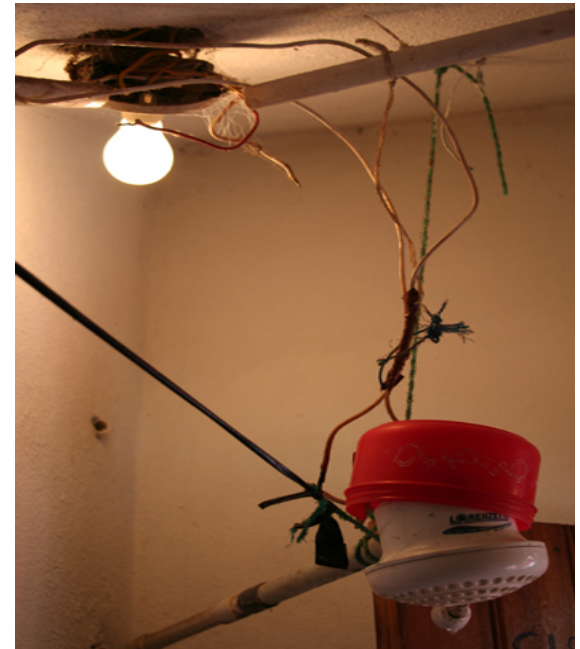
Handyman dangers in the extreme. Unfortunately dangers such as this are so often present

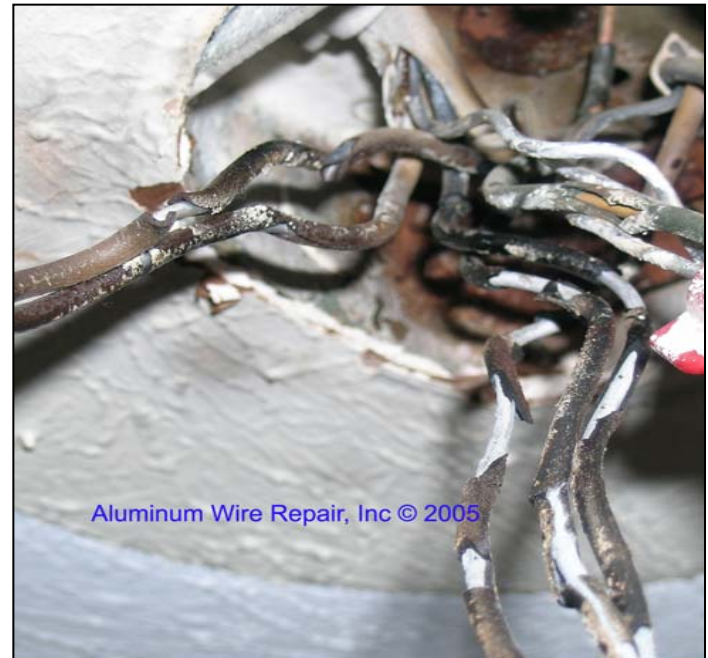
Over heated conductors as a result of overrating of fuses and/or breakers

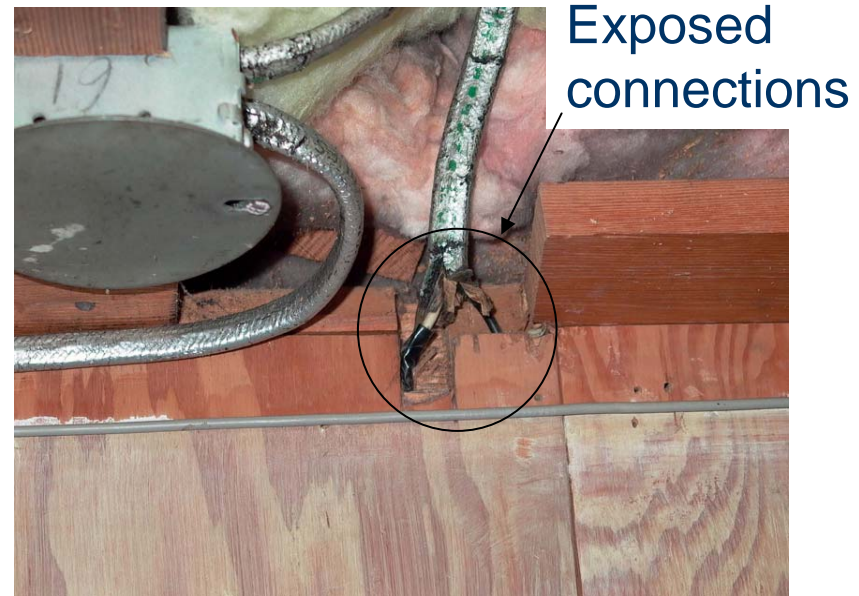
Handyman add-on supplies power to New Westminster basement suite. Connections are sandwiched between wood. *Very dangerous.*

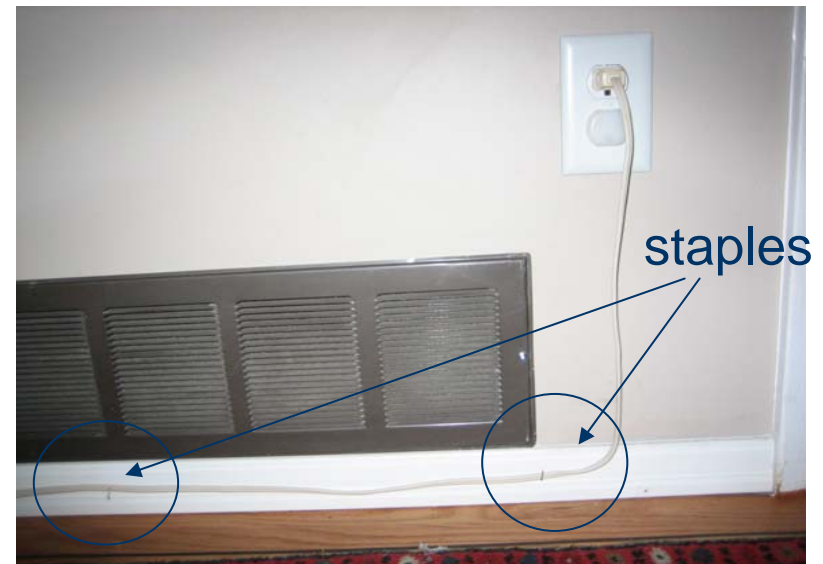
Undersized extension cord used as permanent wiring. Staples provide opportunity for arcing – **Most dangerous and most common**

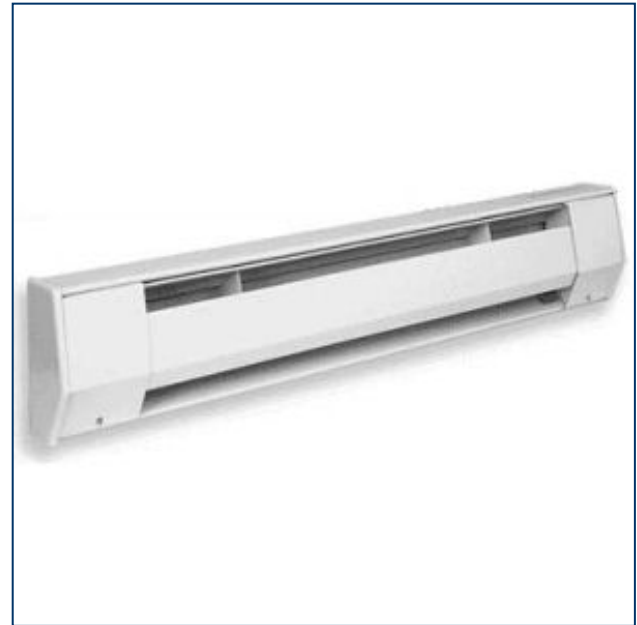
It is surprising how often these are installed under a bookshelf
- Very dangerous

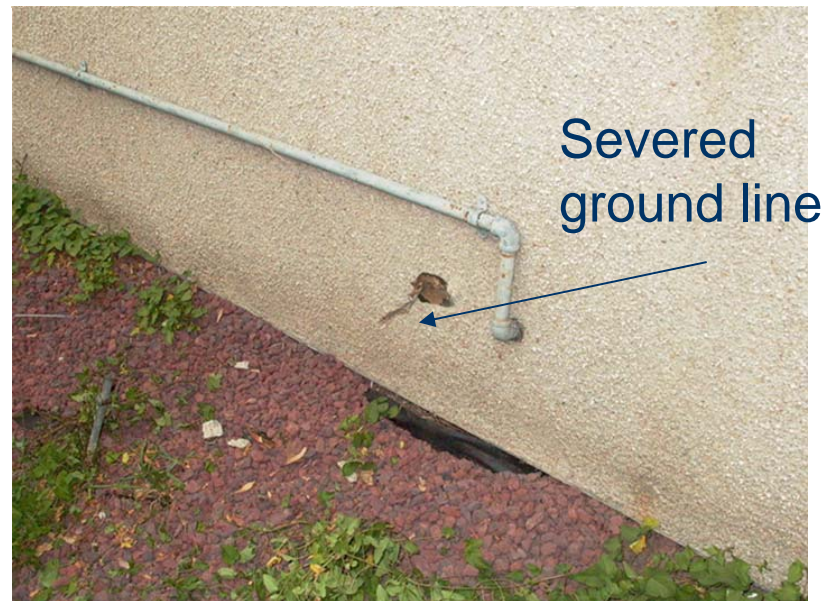
Home electrical ground has been severed; possibly by a lawn mower – *Most dangerous*

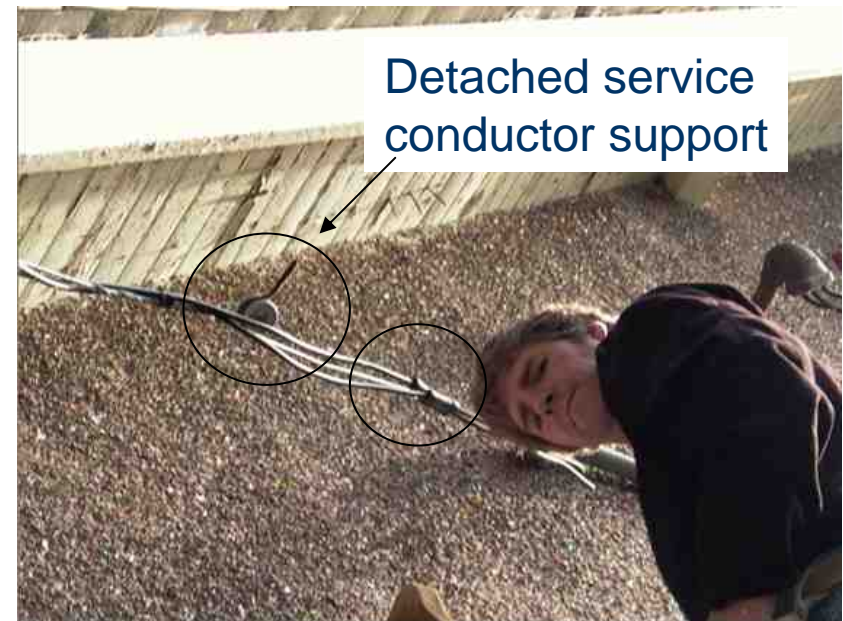
Service conductor support has broken free from side of house, putting tension onto the hot conductor connections (shown right)

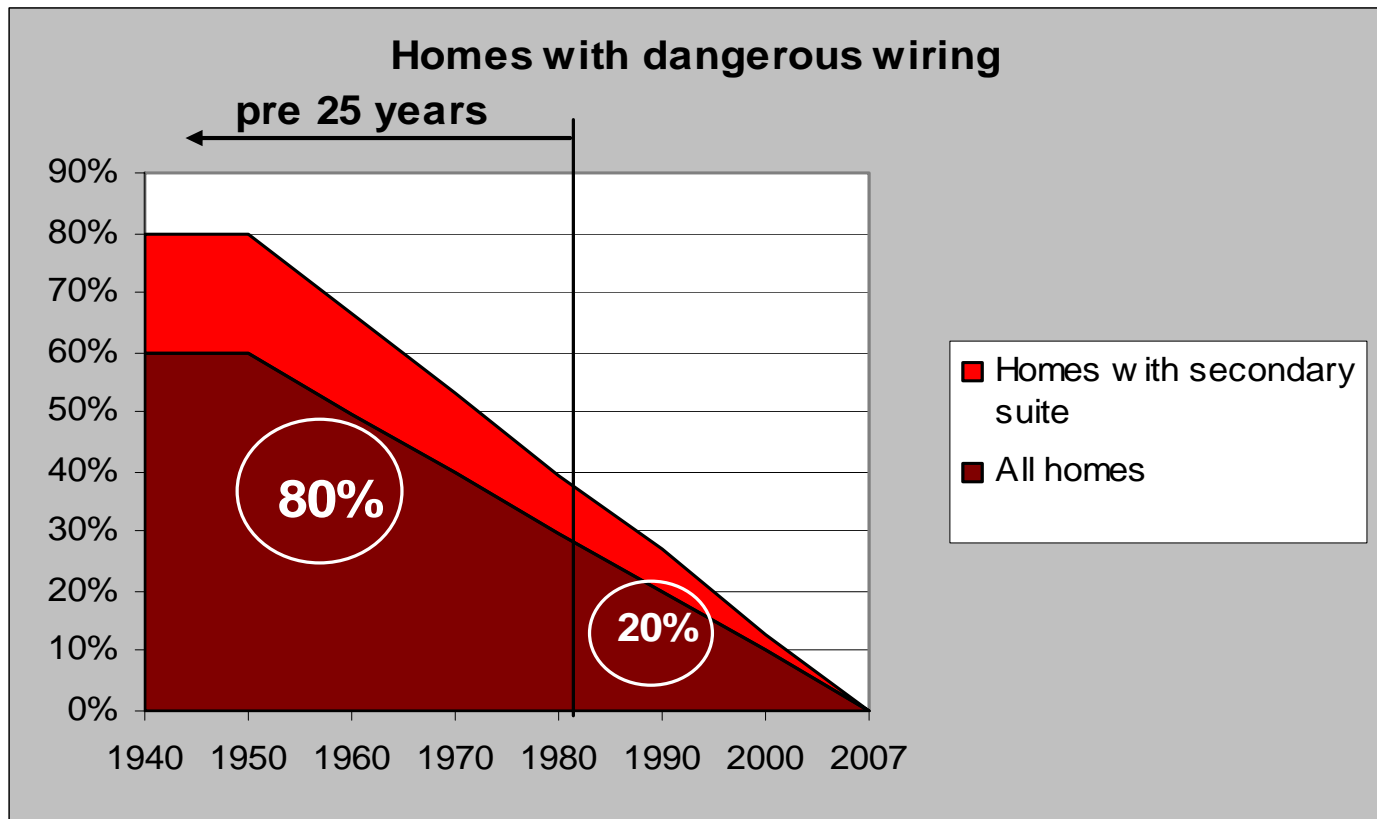
Risk vs. age of home
