# Hazards of Electrical Wiring in Older Buildings

by Brian Cook

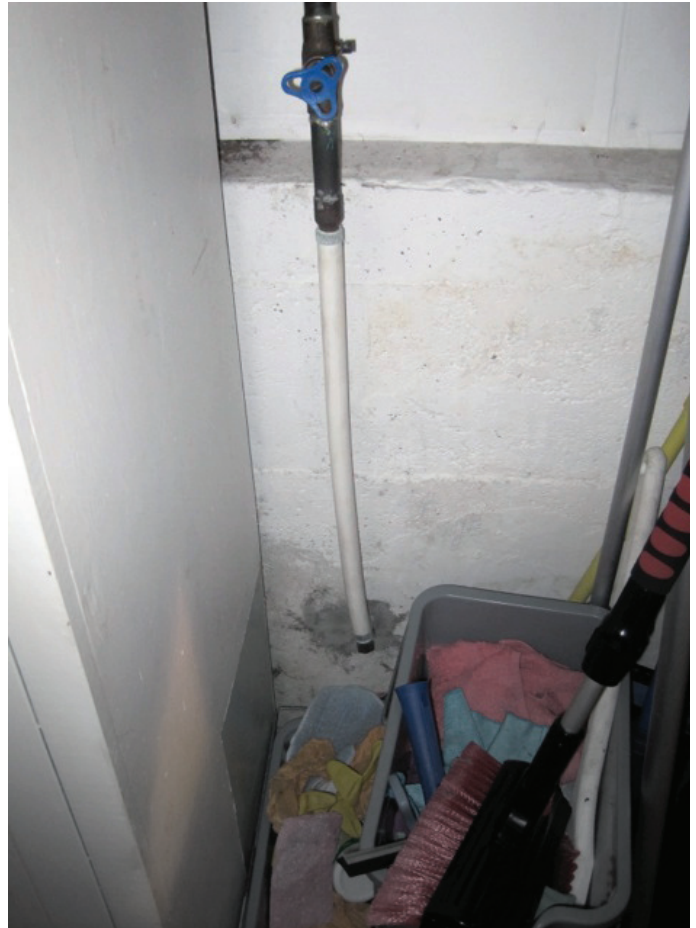
**Broken ground due to water pipe repair with PEX**

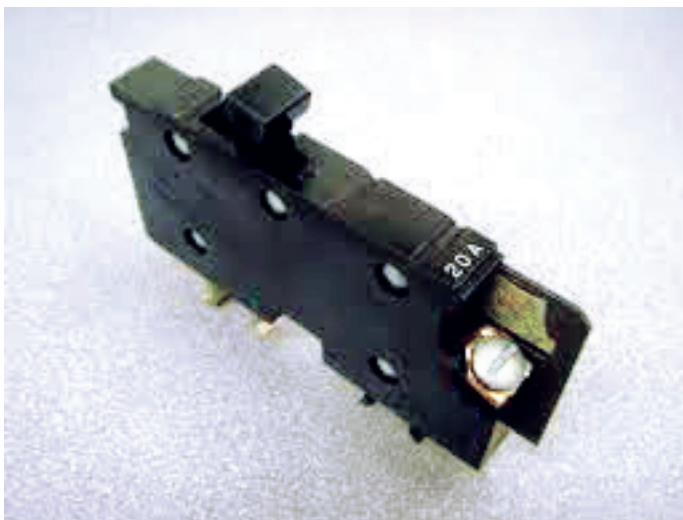
**Faulty circuit breaker**

Study after study show, the vast majority of electrical fires in homes are a result of “handyman tinkering”, that being unauthorized individuals having made changes or additions to the original electrical system; changes or additions that were not in compliance with the electrical code. Handyman tinkering was particularly prominent in the 1960s, ‘70s, ‘80s and the ‘90s during time of home renovation. Faulty circuit breakers also play a significant role in causing electrical fires. One test conducted in

British Columbia in the 1970s found that circuit breakers over 15 to 20 years old were faulty, resulting in electrical fires. Deterioration of electrical conductors does occur if subjected to electrical or physical abuse, regardless of conductor type. Modern electrical cables are just as often found to be in a state of peril as are knob-and-tube conductors. Live electrical cables dangling in basements, from disconnected electric water heaters, disconnected when the electric water heater was replaced with a gas heater are often found.

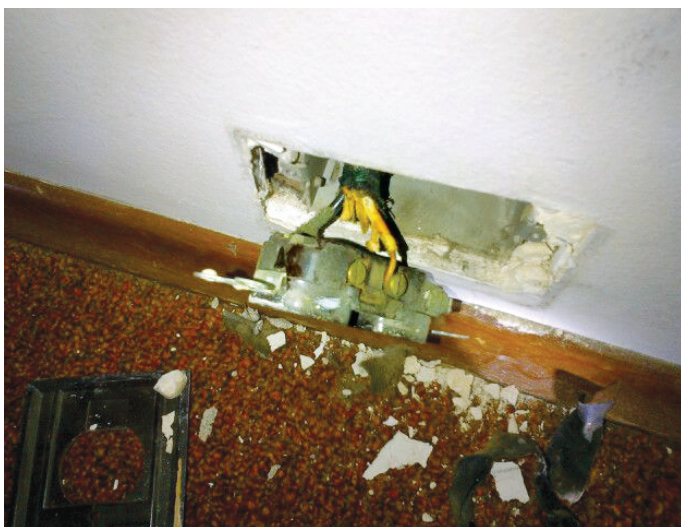
**3-prong outlet on ungrounded cable**

Unfortunately many homeowners, for simply decorative reasons or providing power to their 3-prong electrical appliances, swapped their existing 2-prong, knob-and-tube fed receptacles with the modern 3-prong receptacles, without also providing the necessary ground protection. This “retrofit” is hazardous, as it provides an opportunity to plug-in equipment requiring ground protection, when in fact there is none.

Fortunately there is a simple and cost effective solution to providing ground protection to knob-and-tube fed receptacles, providing the rest of the electrical system has not been tampered with: **The Ground Fault Circuit Interrupter (GFCI)**. GFCIs provide excellent ground protection to receptacles where a grounding-means does not exist. Compared to knob-and-tube replacement the installation of GFCIs is easy to do. The GFCIs can be installed locally or at the panel. GFCIs provide a safe and inexpensive solution for ground protection of ungrounded (knob-and-tube) circuits.

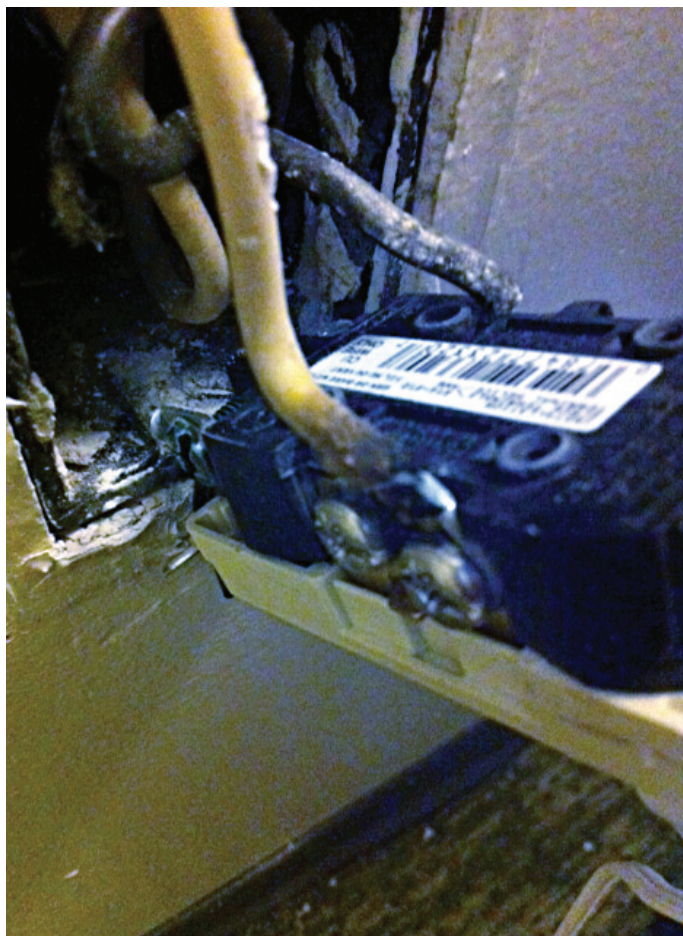
**Aluminum wire on copper outlet**

During normal loading, electrical circuits heat up and cool down. In response to thermal cycling, aluminum expands and contracts at three times the rate of copper. Every time a circuit is used, the aluminum connections expand and contract ever-so-slightly; eventually creating a gap that exposes the wire to air. In contact with copper wire or brass screws of a receptacle for example, aluminum oxide is formed at the connection

point. Aluminum oxide is a poor electrical conductor and will heat under an electrical load. This creates a snowballing effect, escalating the heat generated and the further formation of aluminum oxide. Eventually, with the combination of the heat combined with the loose connection a spark can occur which can start a fire.
