STAY SAFE!

ELECTRICAL FIRES ARE ALL TOO FREQUENT!

FOUR AREAS OF THE HOUSE TO EXAMINE

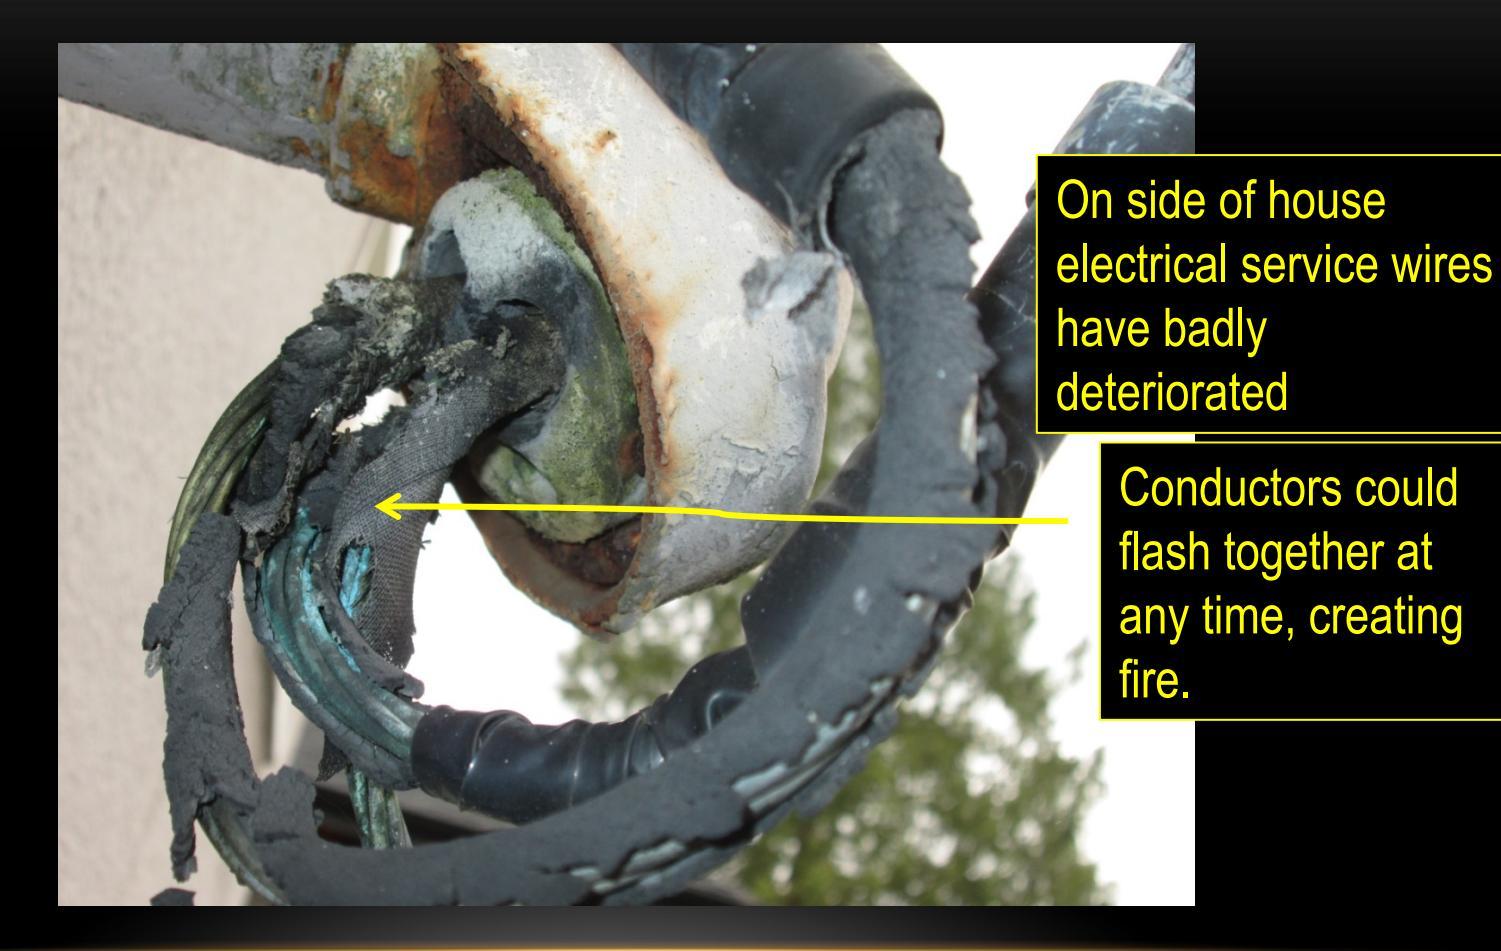
IN THIS WELL KEPT OLDER HOME

SERVICE HAD SERIOUS FIRE HAZARD PRESENT, NOT RECOGNIZED BY THE HOMEOWNER

IMMEDIATE ATTENTION WAS REQUESTED & HOUSE WAS MADE SAFE

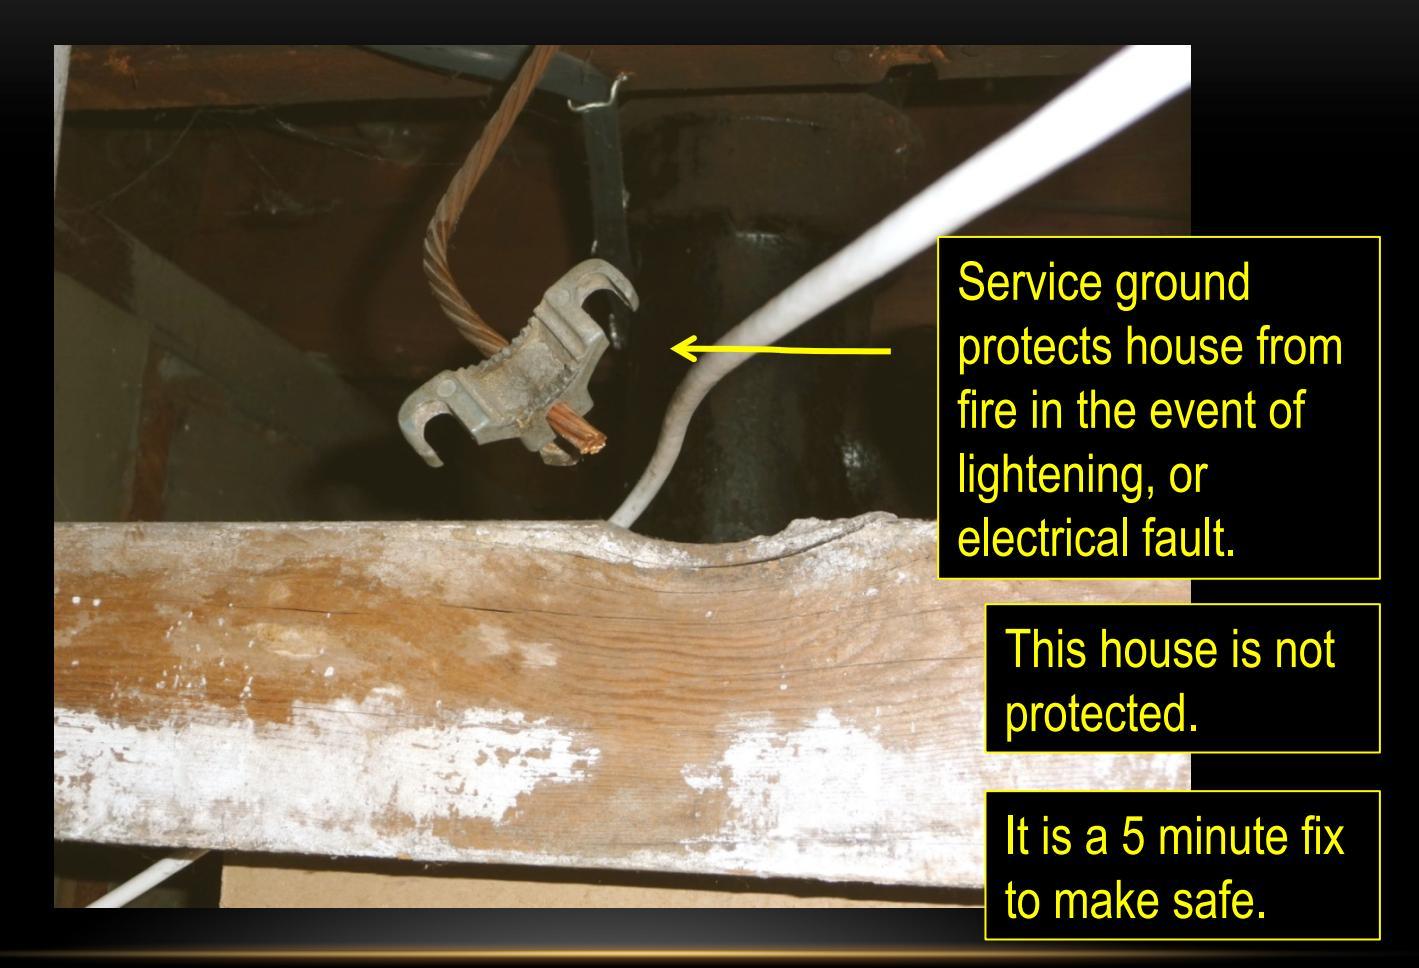
IN ANOTHER HOUSE: GROUND HAS BEEN BROKEN DUE TO A DETACHED CLAMP

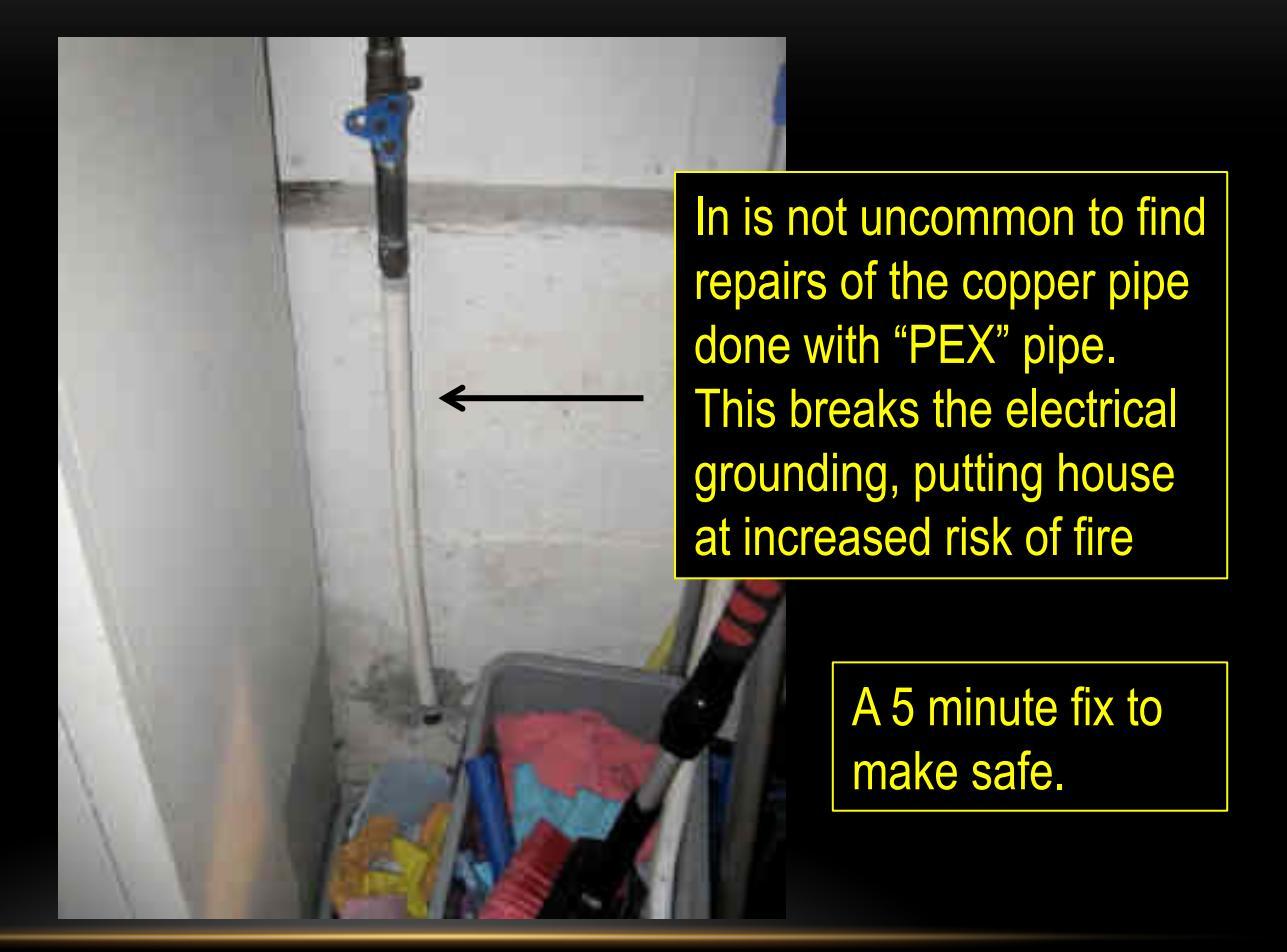
IN THIS HOUSE: GROUND WAS BROKEN DUE TO PLUMBING REPAIRS

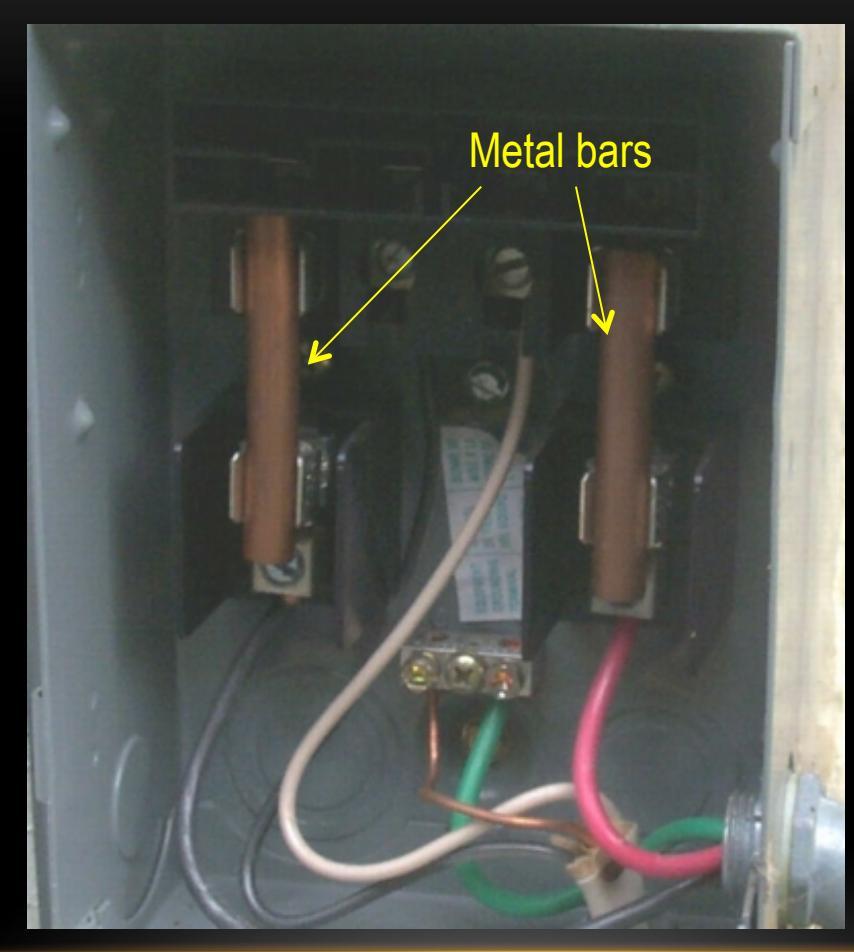
IN THIS HOUSE: FUSES IN MAIN DISCONNECT WERE REPLACED WITH METAL BARS, PUTTING HOUSE AT RISK OF FIRE

Two illegal suites were added to the home. The main fuses would regularly blow as the service size was not sufficient.

Handyman solved the problem by replacing main fuses with metal bars, creating a fire hazard in the process.

House was rated Extreme Risk.

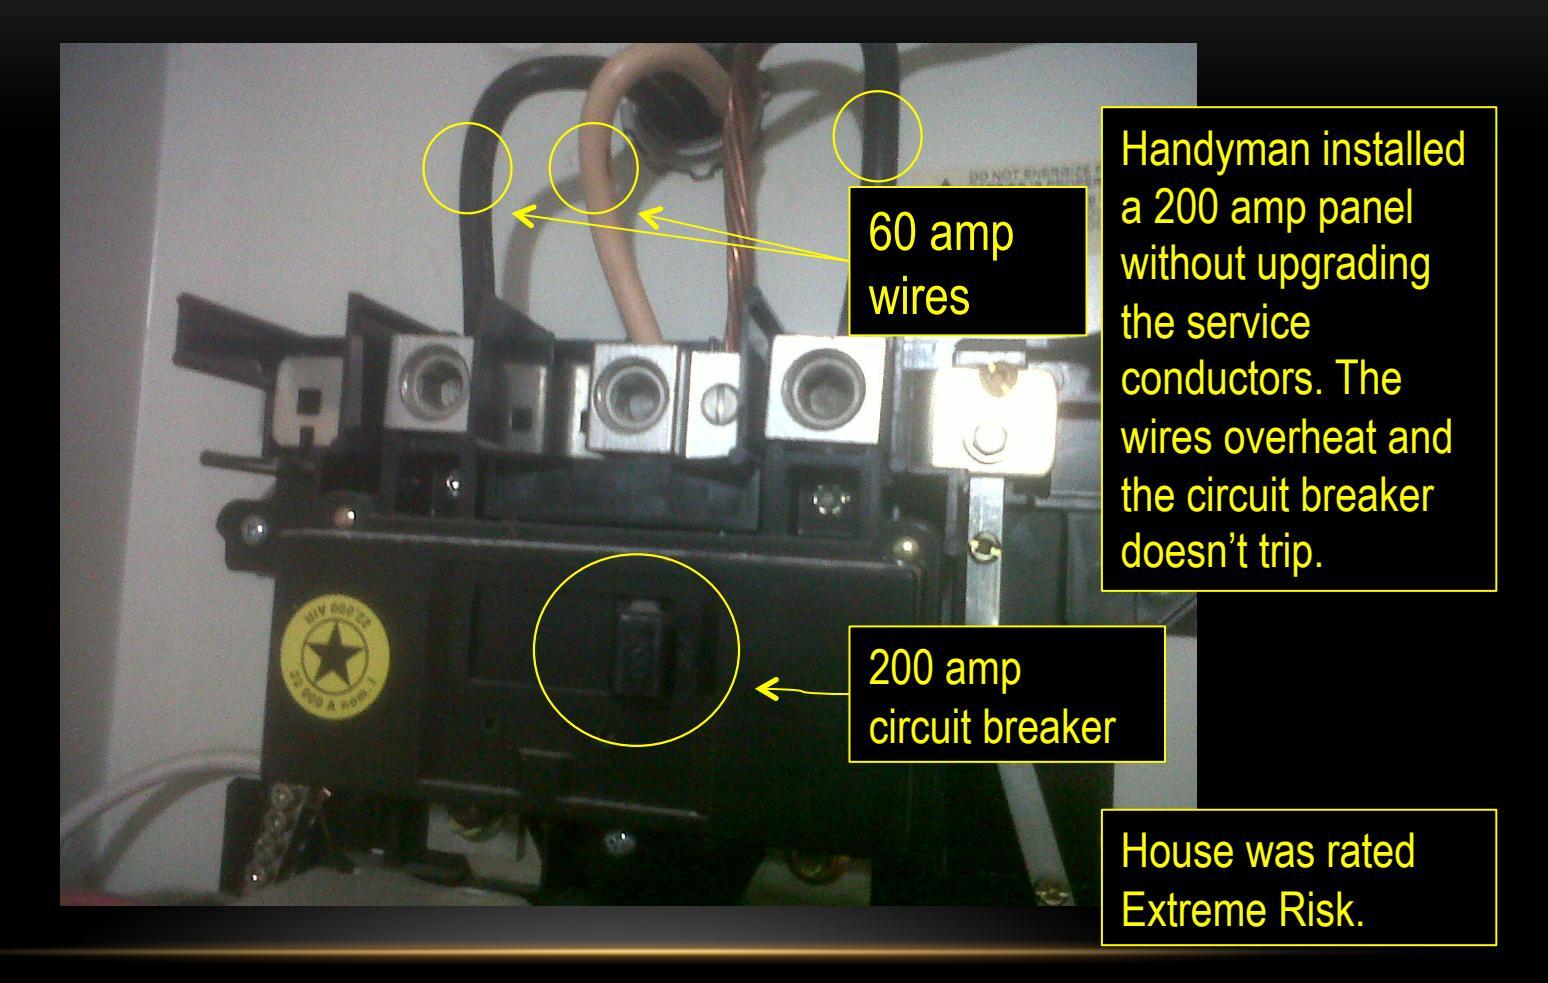
IN THIS HOUSE, PANELBOARD WAS ILLEGALLY UPGRADED TO 200 AMPS, PUTTING HOUSE AT RISK OF FIRE

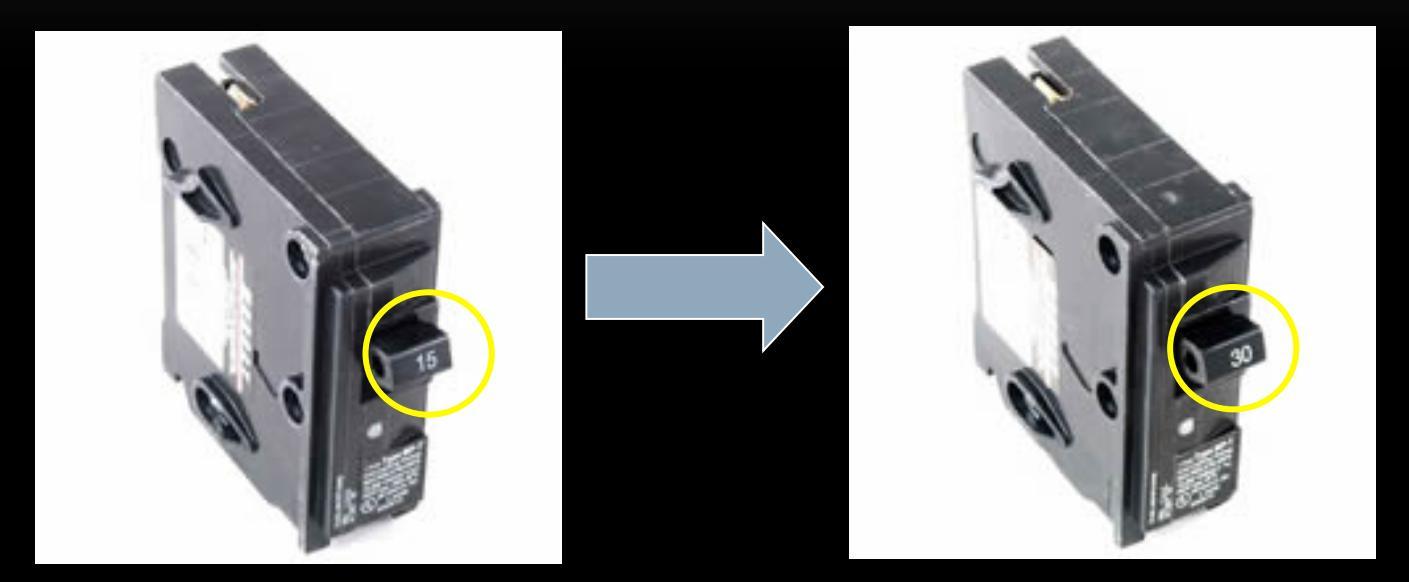
OVERSIZED BREAKERS: COMMON IN OLD HOUSES PUTTING HOUSE AT RISK OF FIRE

15 amp circuit breaker

30 amp circuit breaker

If a circuit blows due to overloading, often homeowners will replace the breaker with a larger circuit breaker. This is a dangerous action as it defeats the function of the circuit breaker. Common with kitchen counter outlets. The correct repair is to provide an additional outlet circuit.

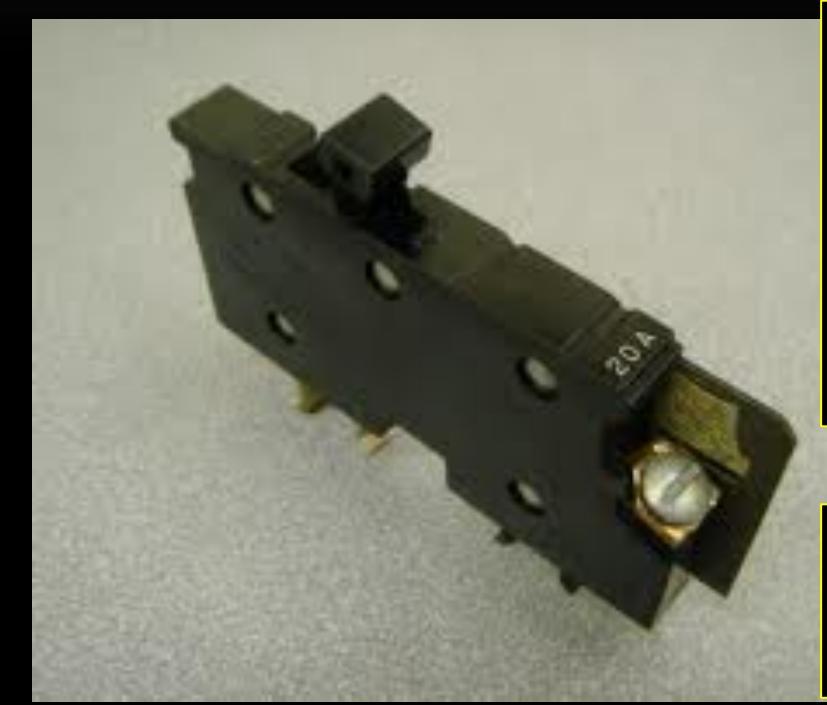
OBSOLETE BREAKERS ARE OFTEN FOUND PUTTING HOUSE AT RISK OF FIRE

Older circuit breakers (pre mid-1960s), such as, "Square D, Type XO" may not trip quickly when needed. Modern breakers, such as "Square D, Type QO" feature internal components to trip quickly.

If these older circuit breakers are identified in homes, they should absolutely be replaced.

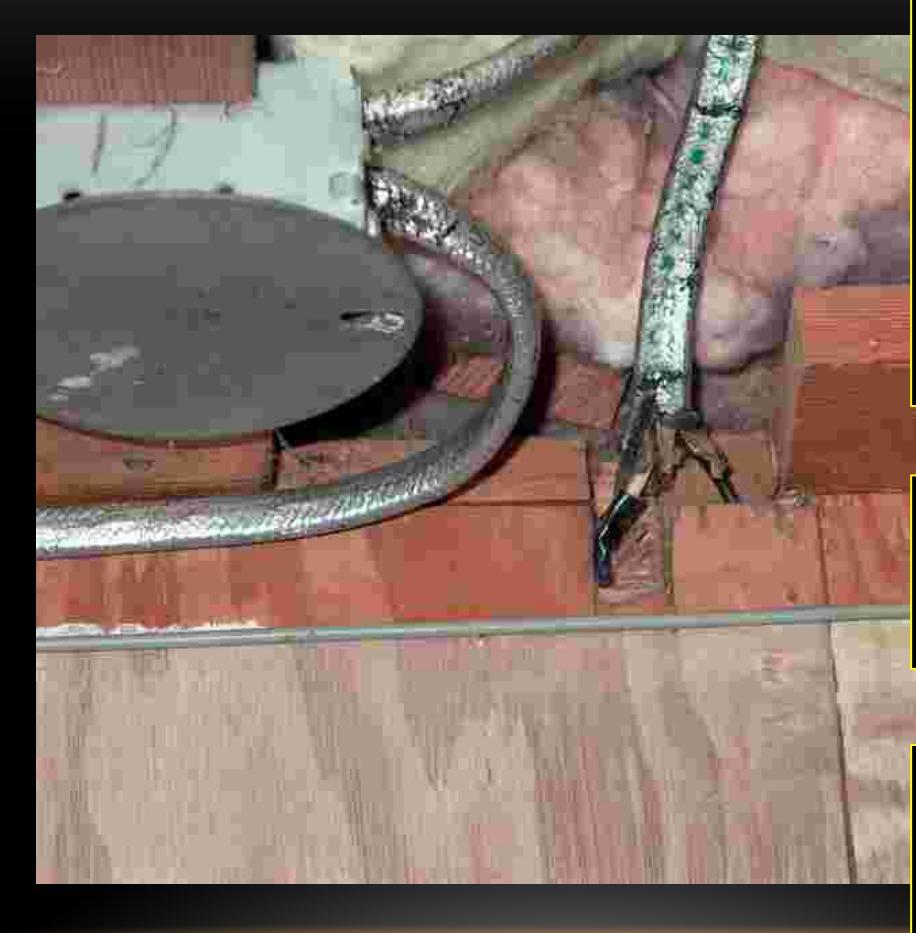
CONNECTIONS NOT IN BOXES

In this home, a handyman added an outlet in the basement. Connections were twisted together and pinched behind the wooden moulding.

If the connections become loose they will spark & create fire.

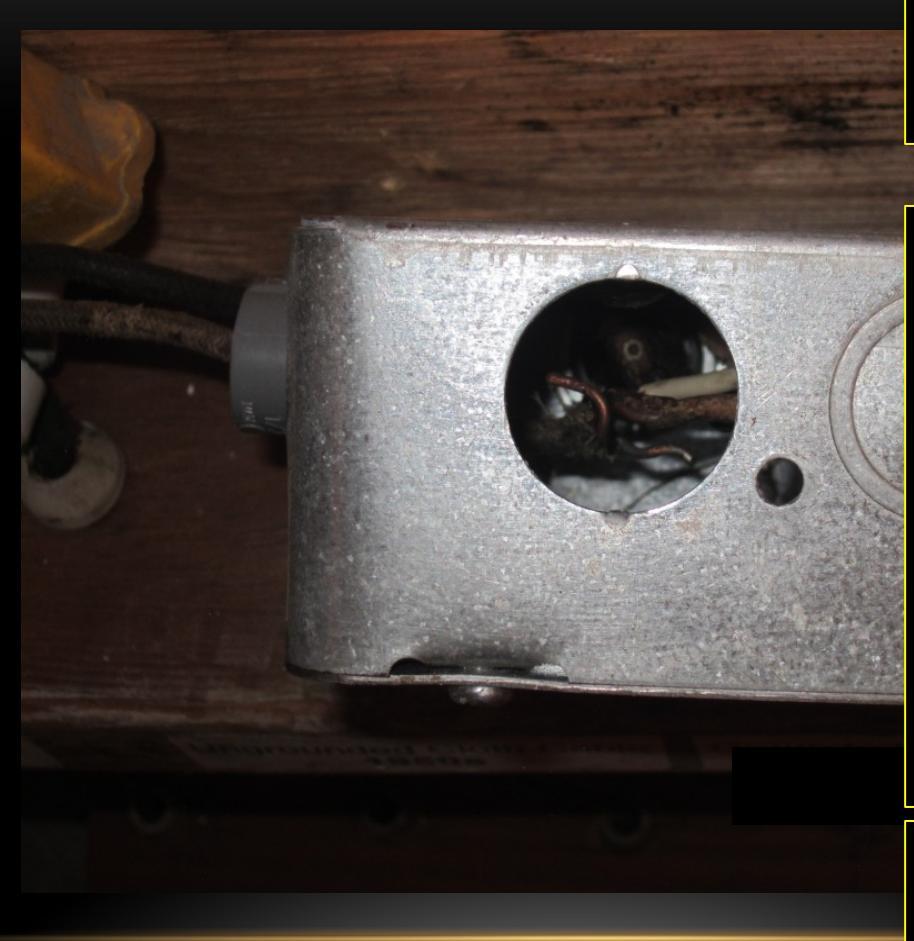
Open holes in boxes are common with handyman work

These holes provide easy access for spiders and rodents seeking the warmth in an electrical box. Should sparks occur at the connections in the box, the debris can easily ignite. Sometimes boxes are full of debris.

Holes can easily be sealed with metal caps.

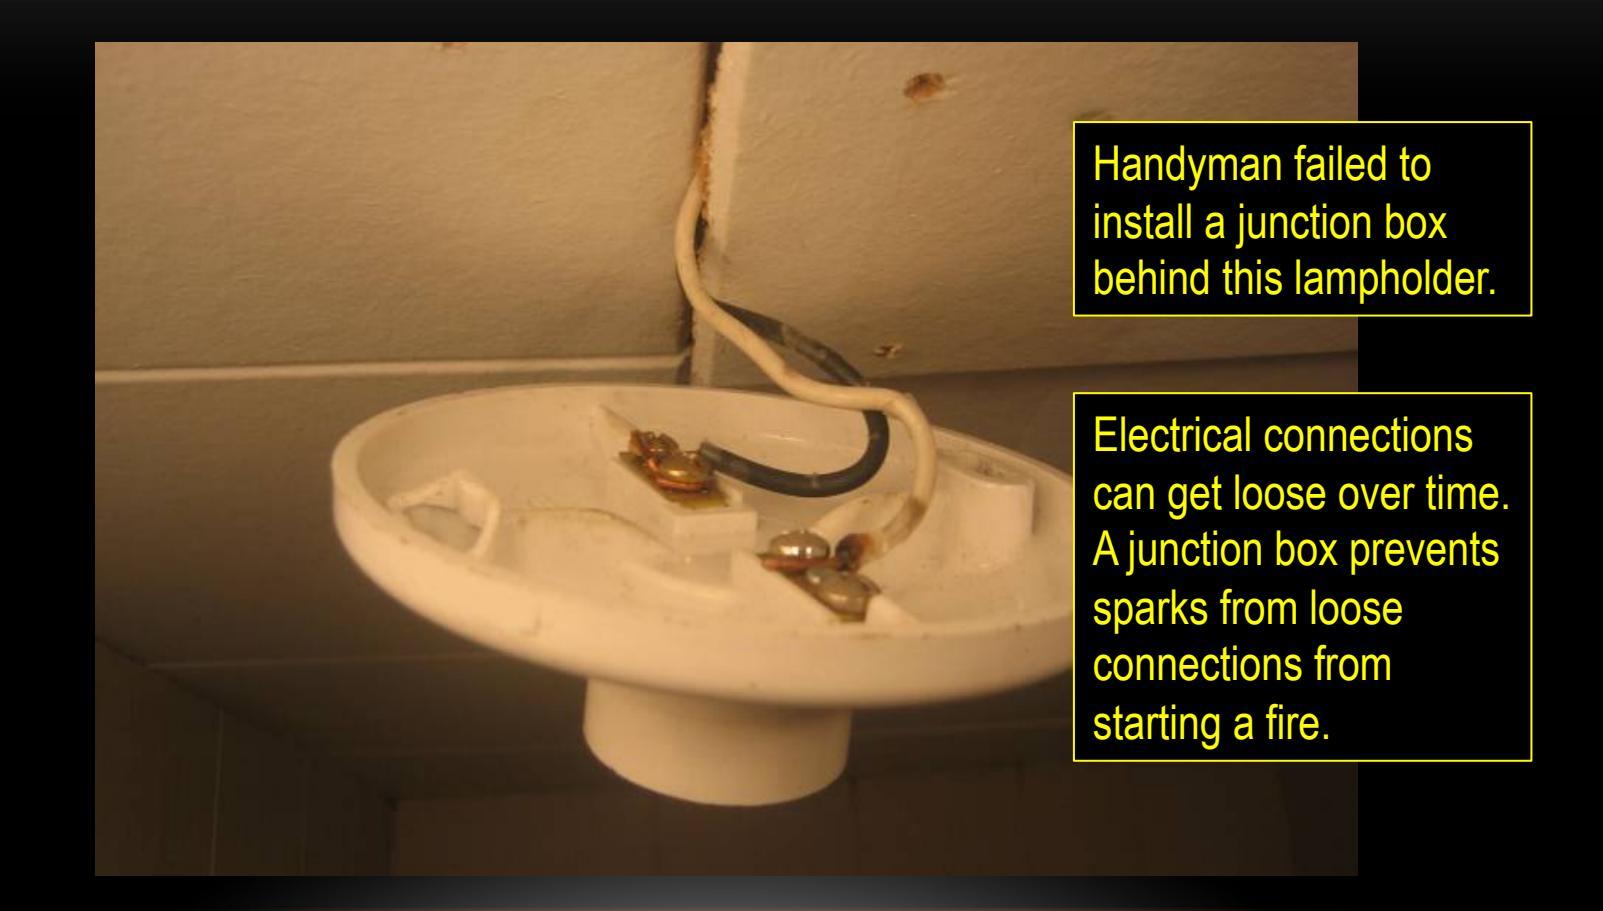
LAMP HOLDER HAZARDOUSLY INSTALLED

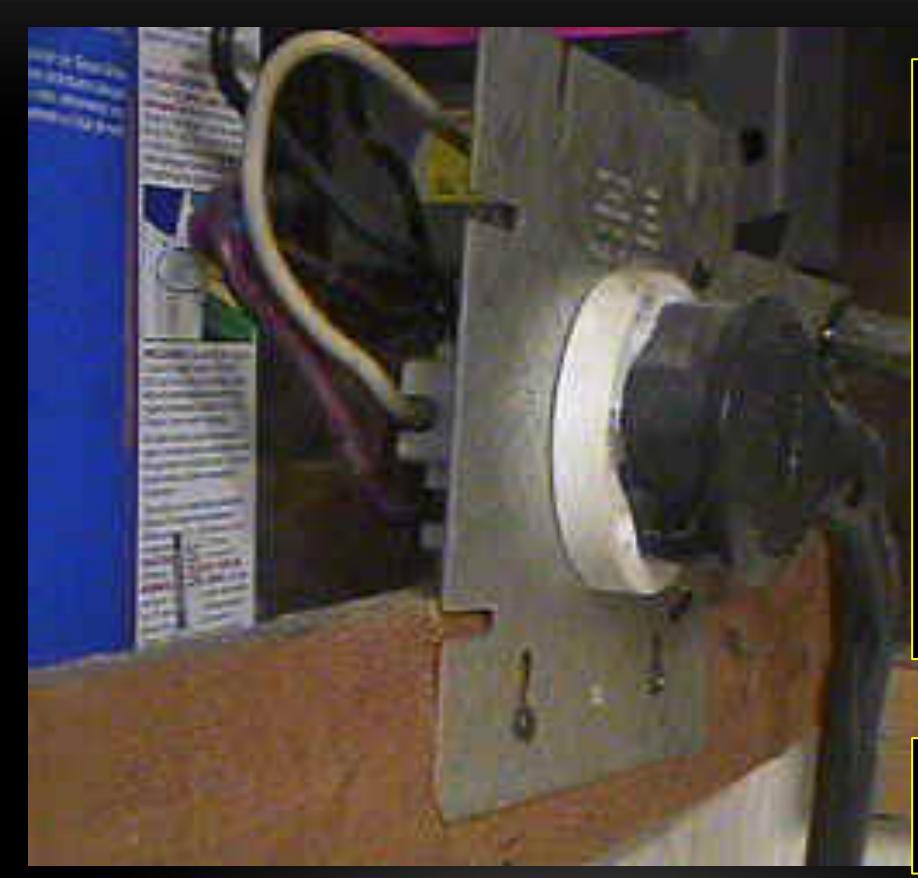
IN OLD HOUSES HANDYMAN ADD-ON CIRCUITS ARE ABUNDANT

An electrical box is required behind all outlets and switches, to prevent sparks from loose connections from starting a fire.

This installer failed to install an electrical box behind this dryer outlet.

To install a box is a 15 minute fix.

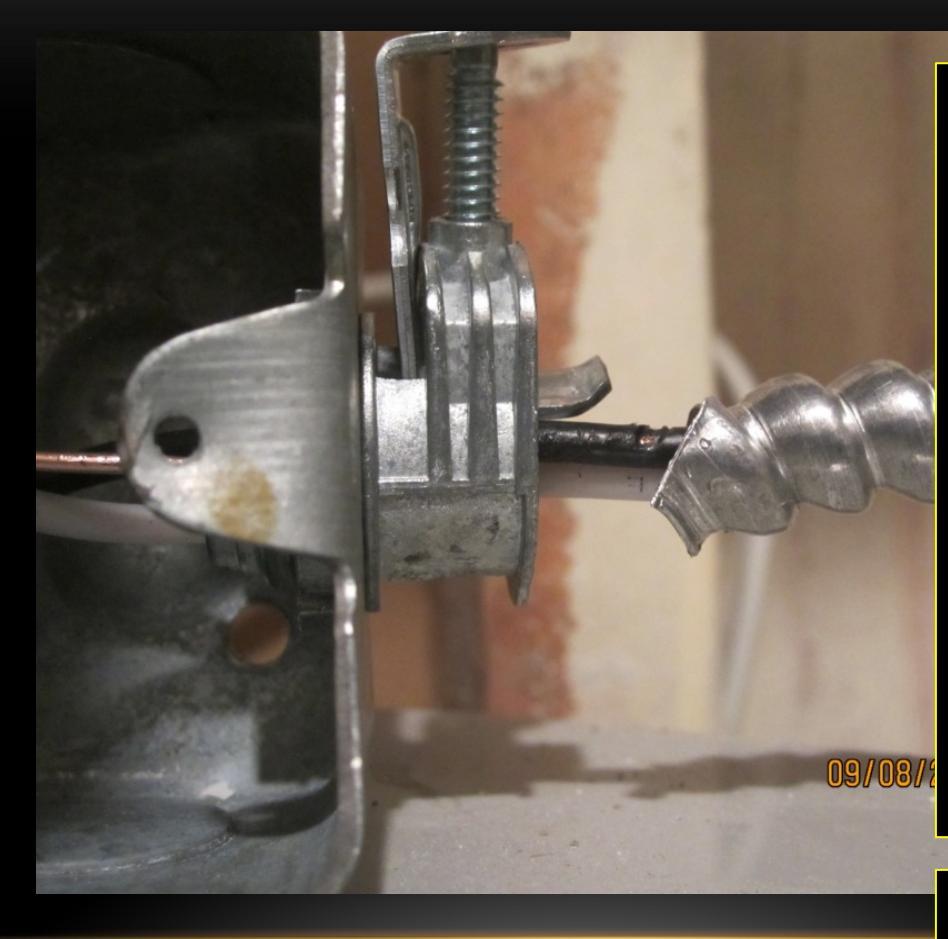
CABLES INSTALLED WITHOUT PROTECTION

Where a metal cable meets the box a protective bushing (aka. Anti-short) is required to protect the sharp edge of the metal casing from cutting the wire.

Installer failed to install an "Anti-short" on this cable to a new furnace, putting house at increased risk of fire"

Anti-shorts take seconds to install.

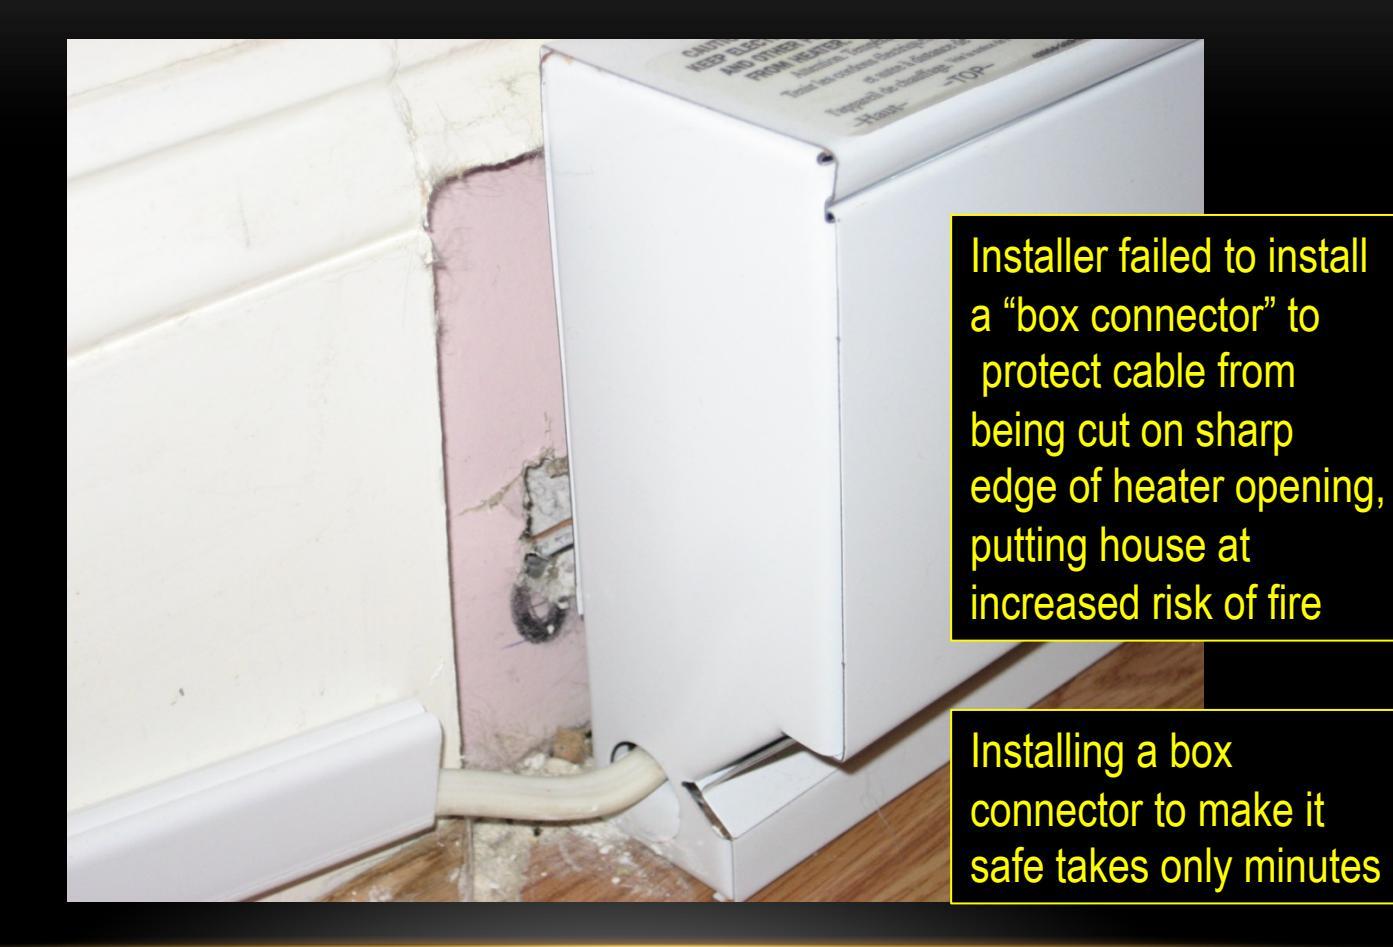
HAZARDOUS BASEBOARD HEATER INSTALLATION

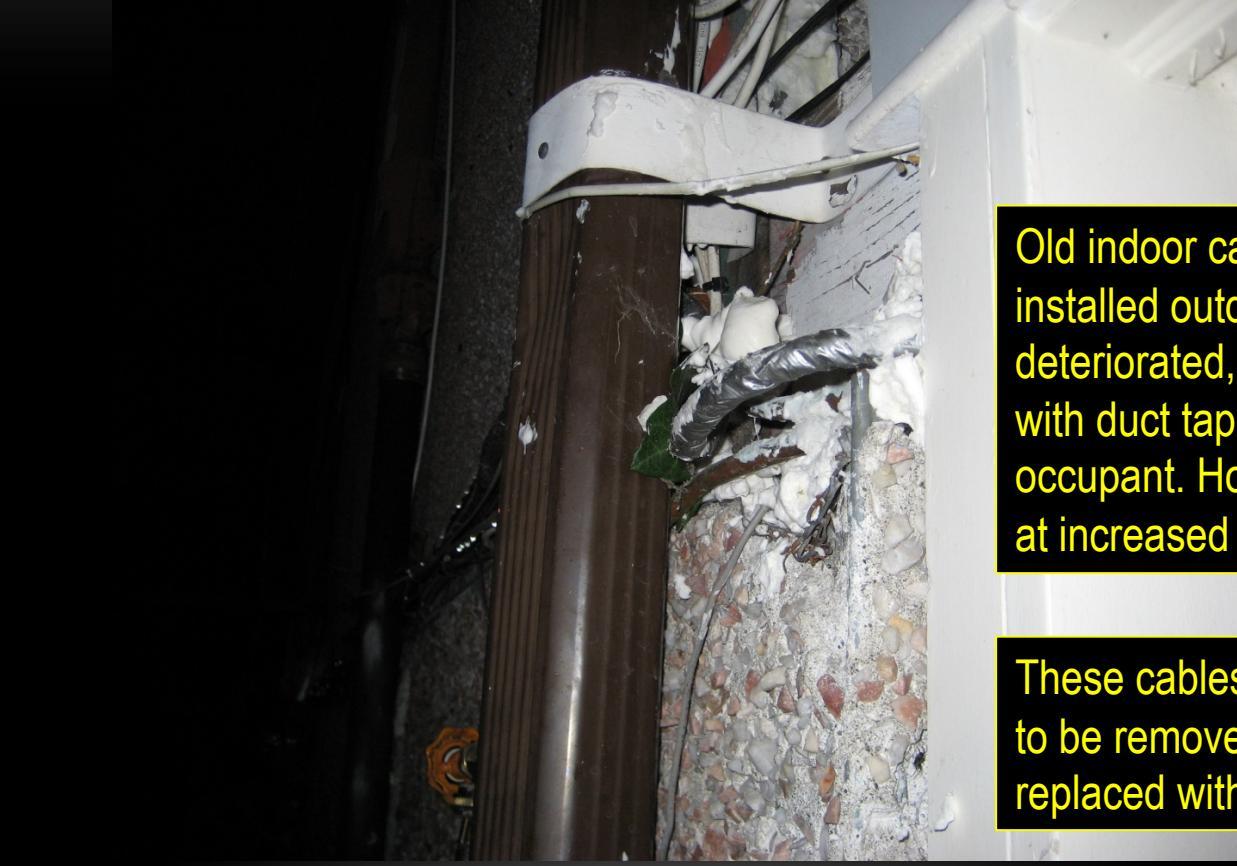
INDOOR CABLES INSTALLED OUTDOORS DETERIORATE OVER TIME

Old indoor cables installed outdoors have deteriorated, now taped with duct tape by occupant. House is now at increased risk of fire.

These cables will need to be removed and replaced with new.

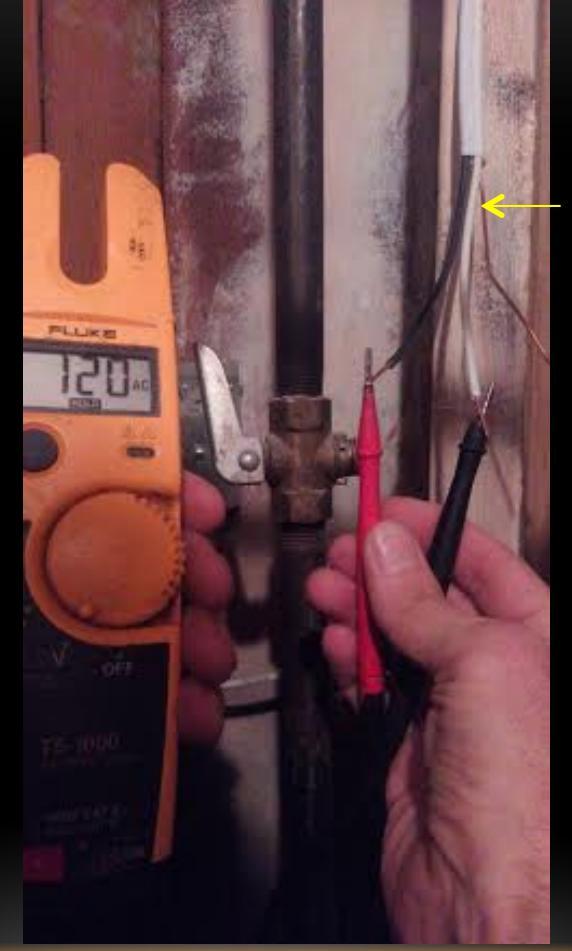
COMMONLY FOUND IN BASEMENTS: ELECTRICAL WIRES DANGLING AND LIVE!

Live electrical wires found millimeters from gas pipe, could cause sparks

Often found in the basement near gas pipe, due to old electric water heater now replaced with gas. House at risk of fire.

Disconnecting the live cable from the panelboard takes only minutes

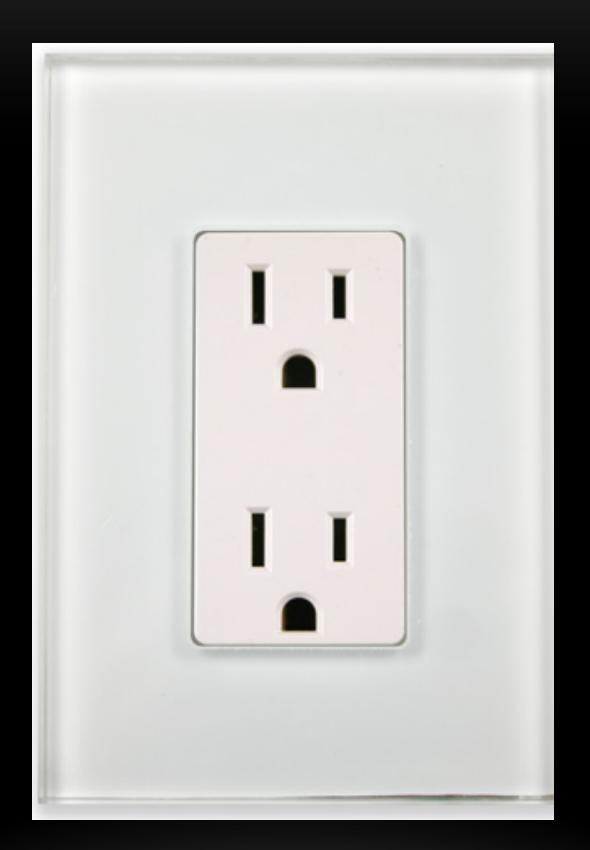
KNOB AND TUBE HAS CONCERNS

Key concern: Knob-&-tube is not compatible with standard modern outlets.

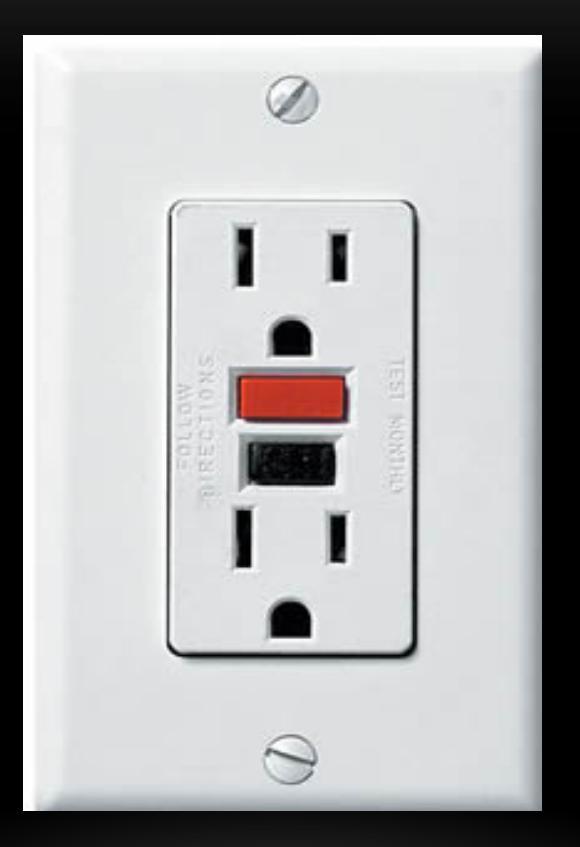
KNOB AND TUBE HAS SOLUTIONS

It can be made compatible by replacing the outlet with a GFCI, or providing GFCI protection at the panel.

This is an excellent and safe solution; and relatively inexpensive.

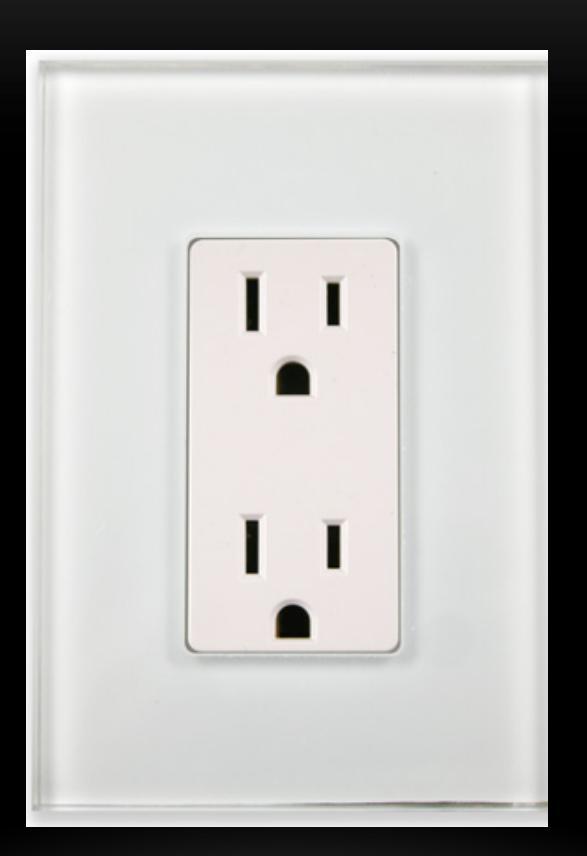
ALUMINUM WIRE ALSO HAS CONCERNS

Key concern: Aluminum wire is not compatible with standard modern outlets

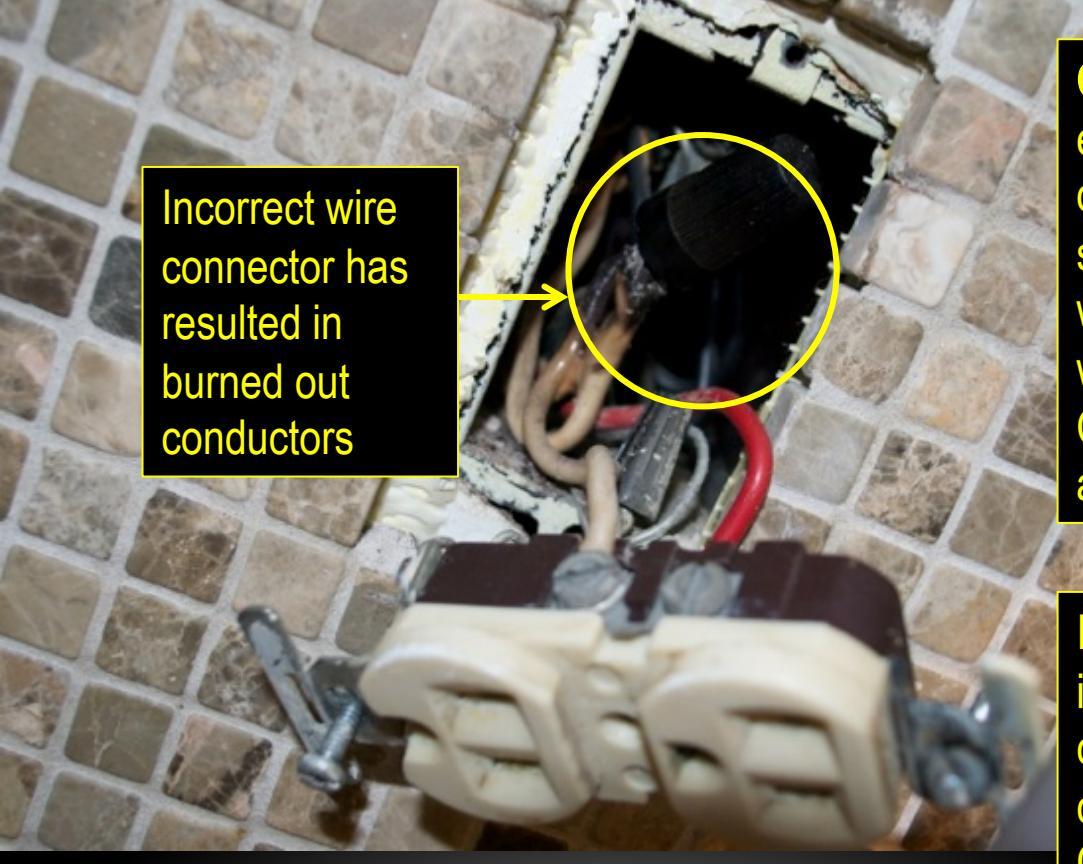
Copper pigtailing is an excellent solution, *if* done correctly. It entails short pieces of copper wire from the aluminum wire to the outlet. Correct wire connectors are essential.

In this example, the incorrect wire connectors were used, creating a Fire Hazard Condition

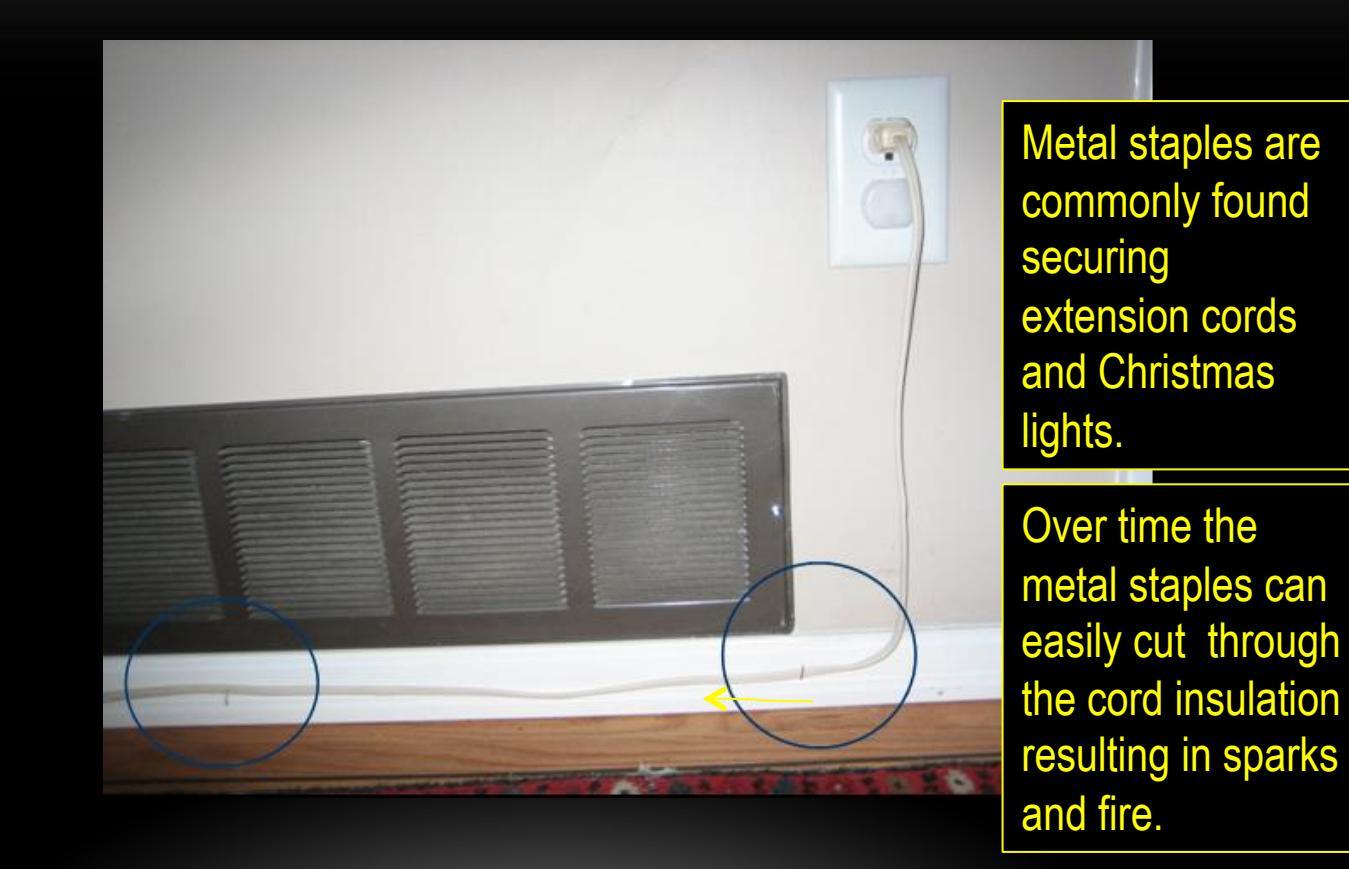
SOME TIDY-UPS DONE BY HOMEOWNERS CREATE SERIOUS FIRE HAZARDS

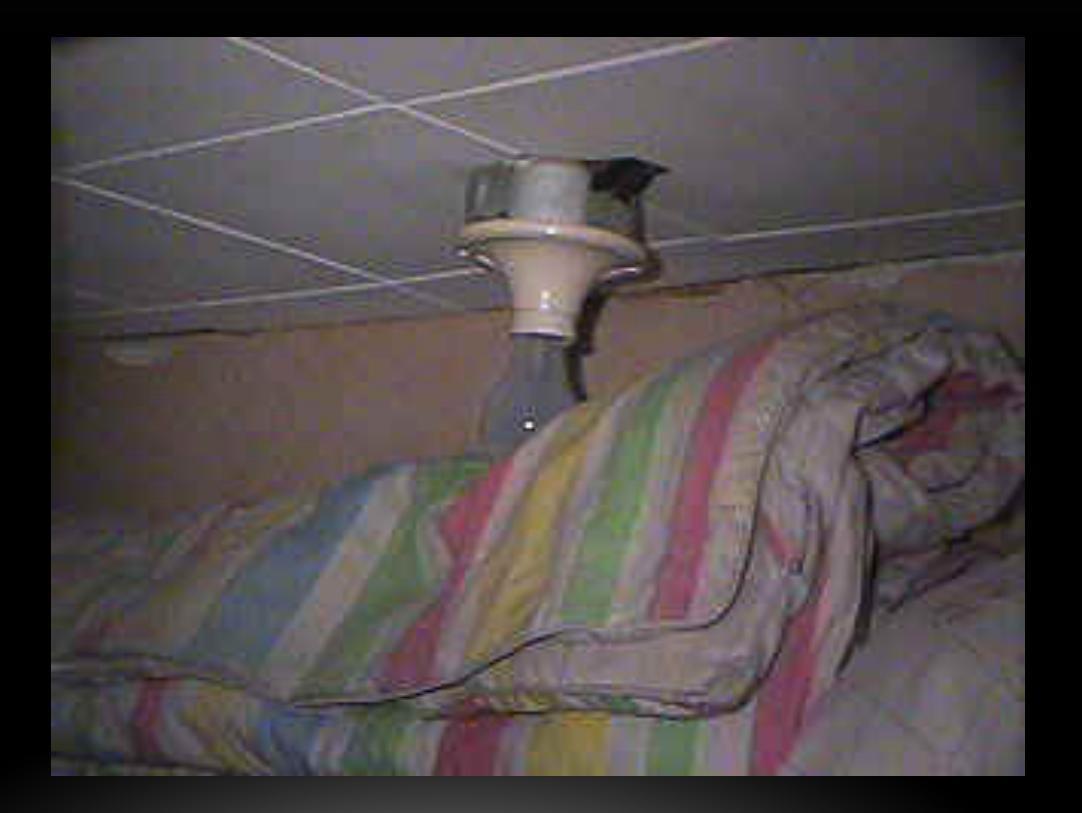
SOME ACTIONS BY OCCUPANTS PUT HOUSE IN FIRE HAZARD CONDITION
